Waterways World

GAS SAFETY: the need for servicing

Don't rely solely on your BSS exam for onboard gas safety. Research by **Tom Keeling** – a registered gas engineer and Chartered Marine Engineer – shows why it's no substitute for regular servicing

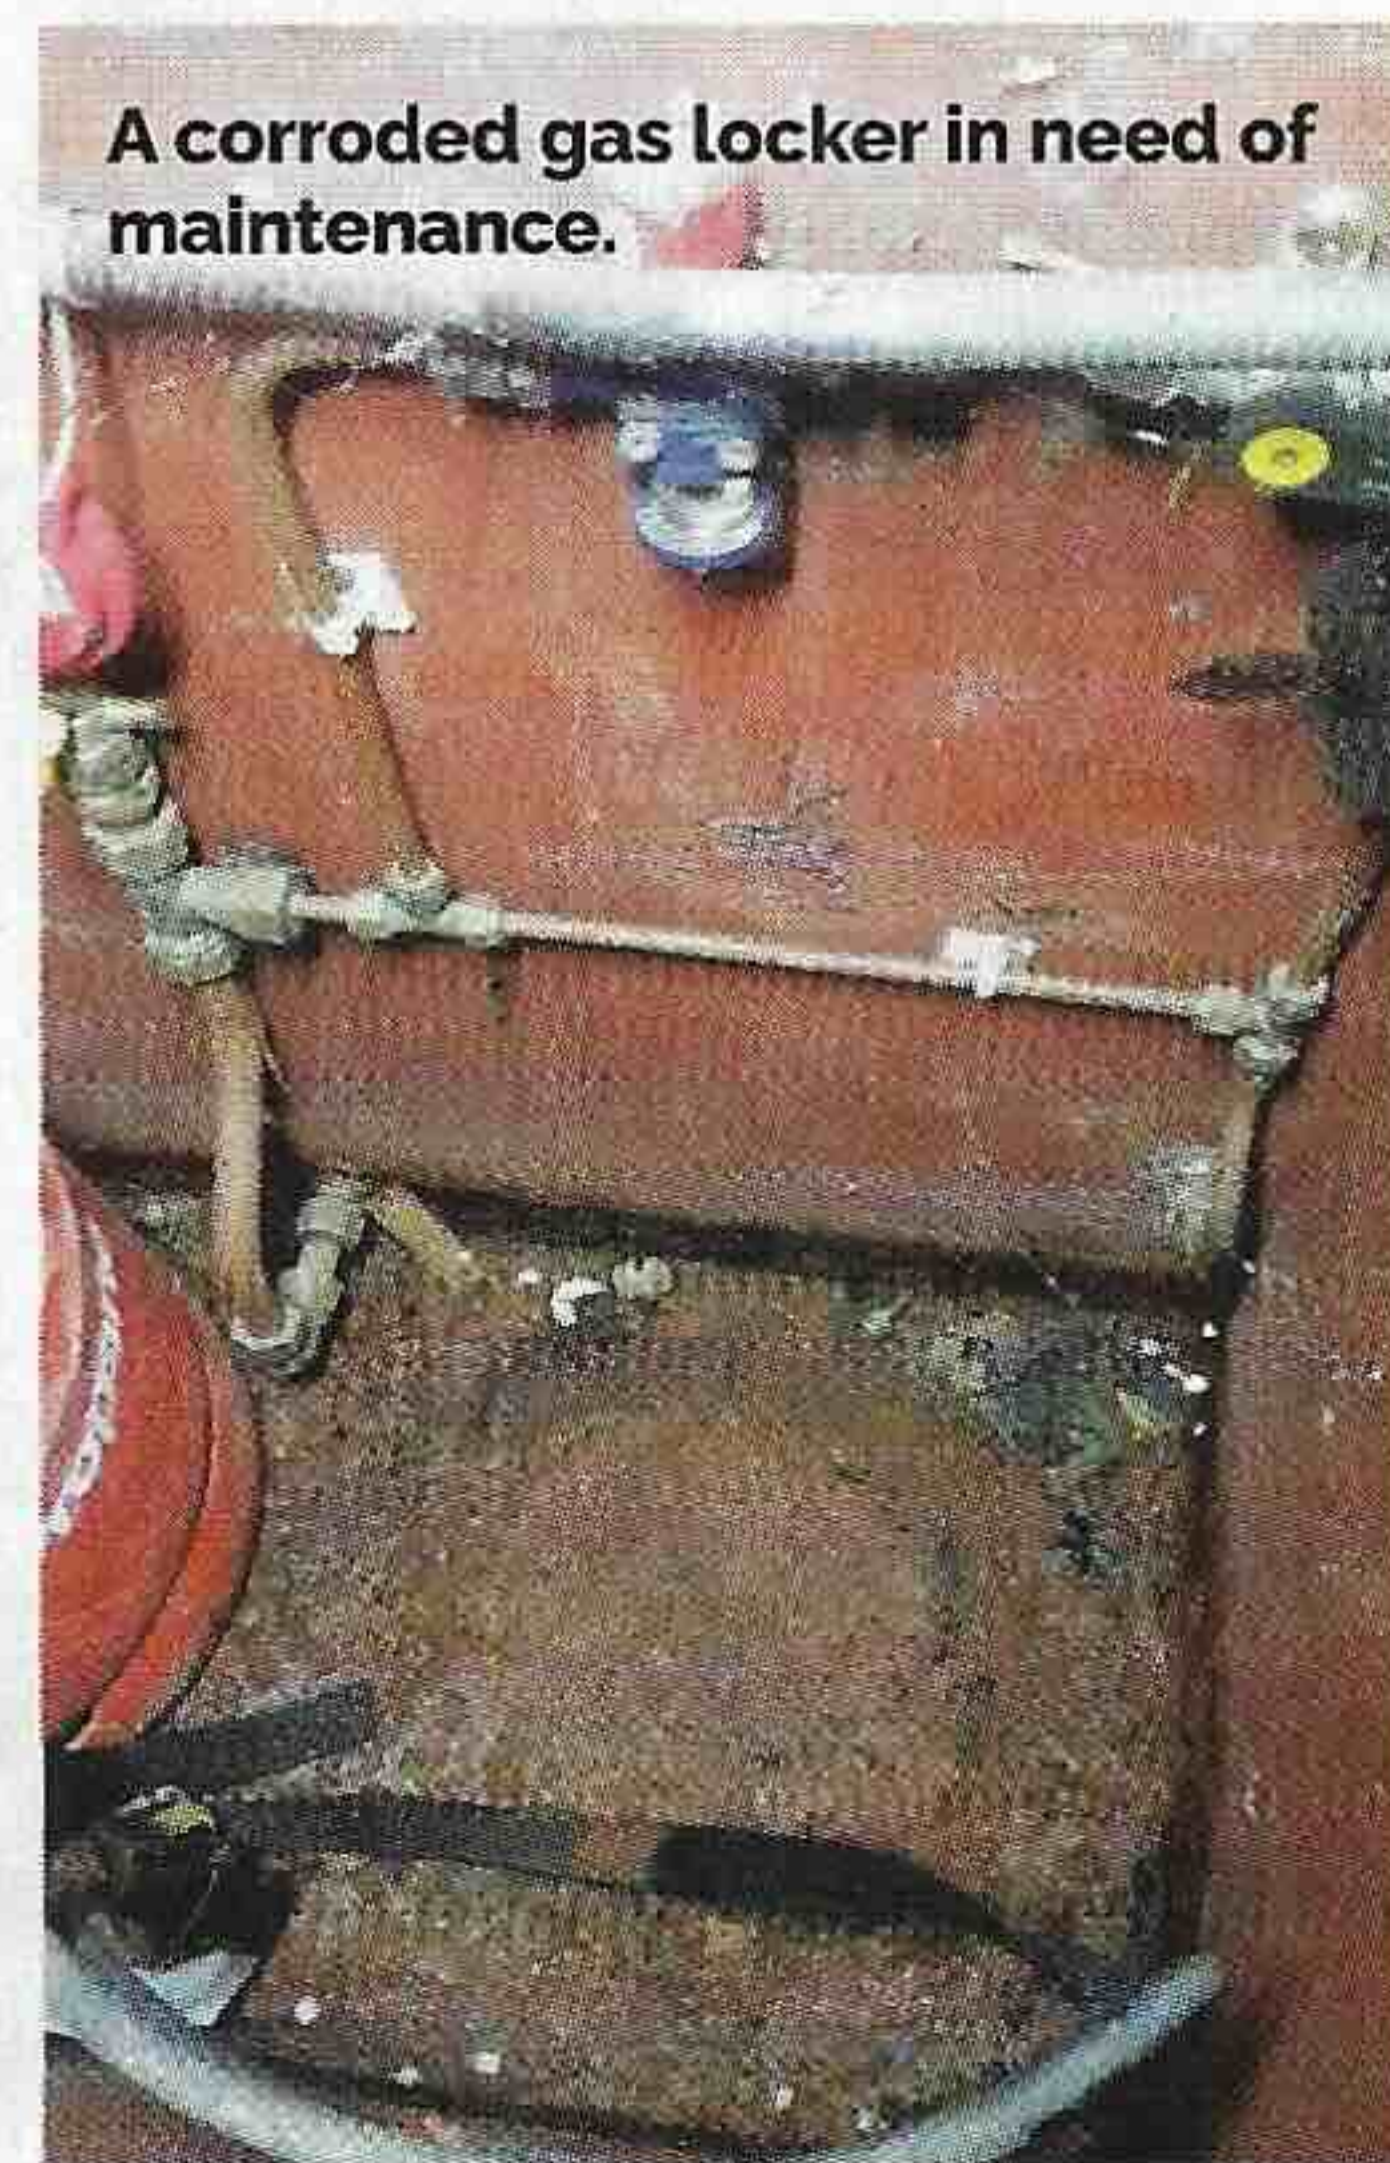
A corroded gas locker in need of maintenance.

during inspection of steel boats is excessive corrosion. Out-of-sight spaces in boats are often last on a list of jobs but keeping the locker good stops any leaked gas entering the boat. This becomes even more crucial where the gas lockers are wet lockers and deterioration can sink the boat.

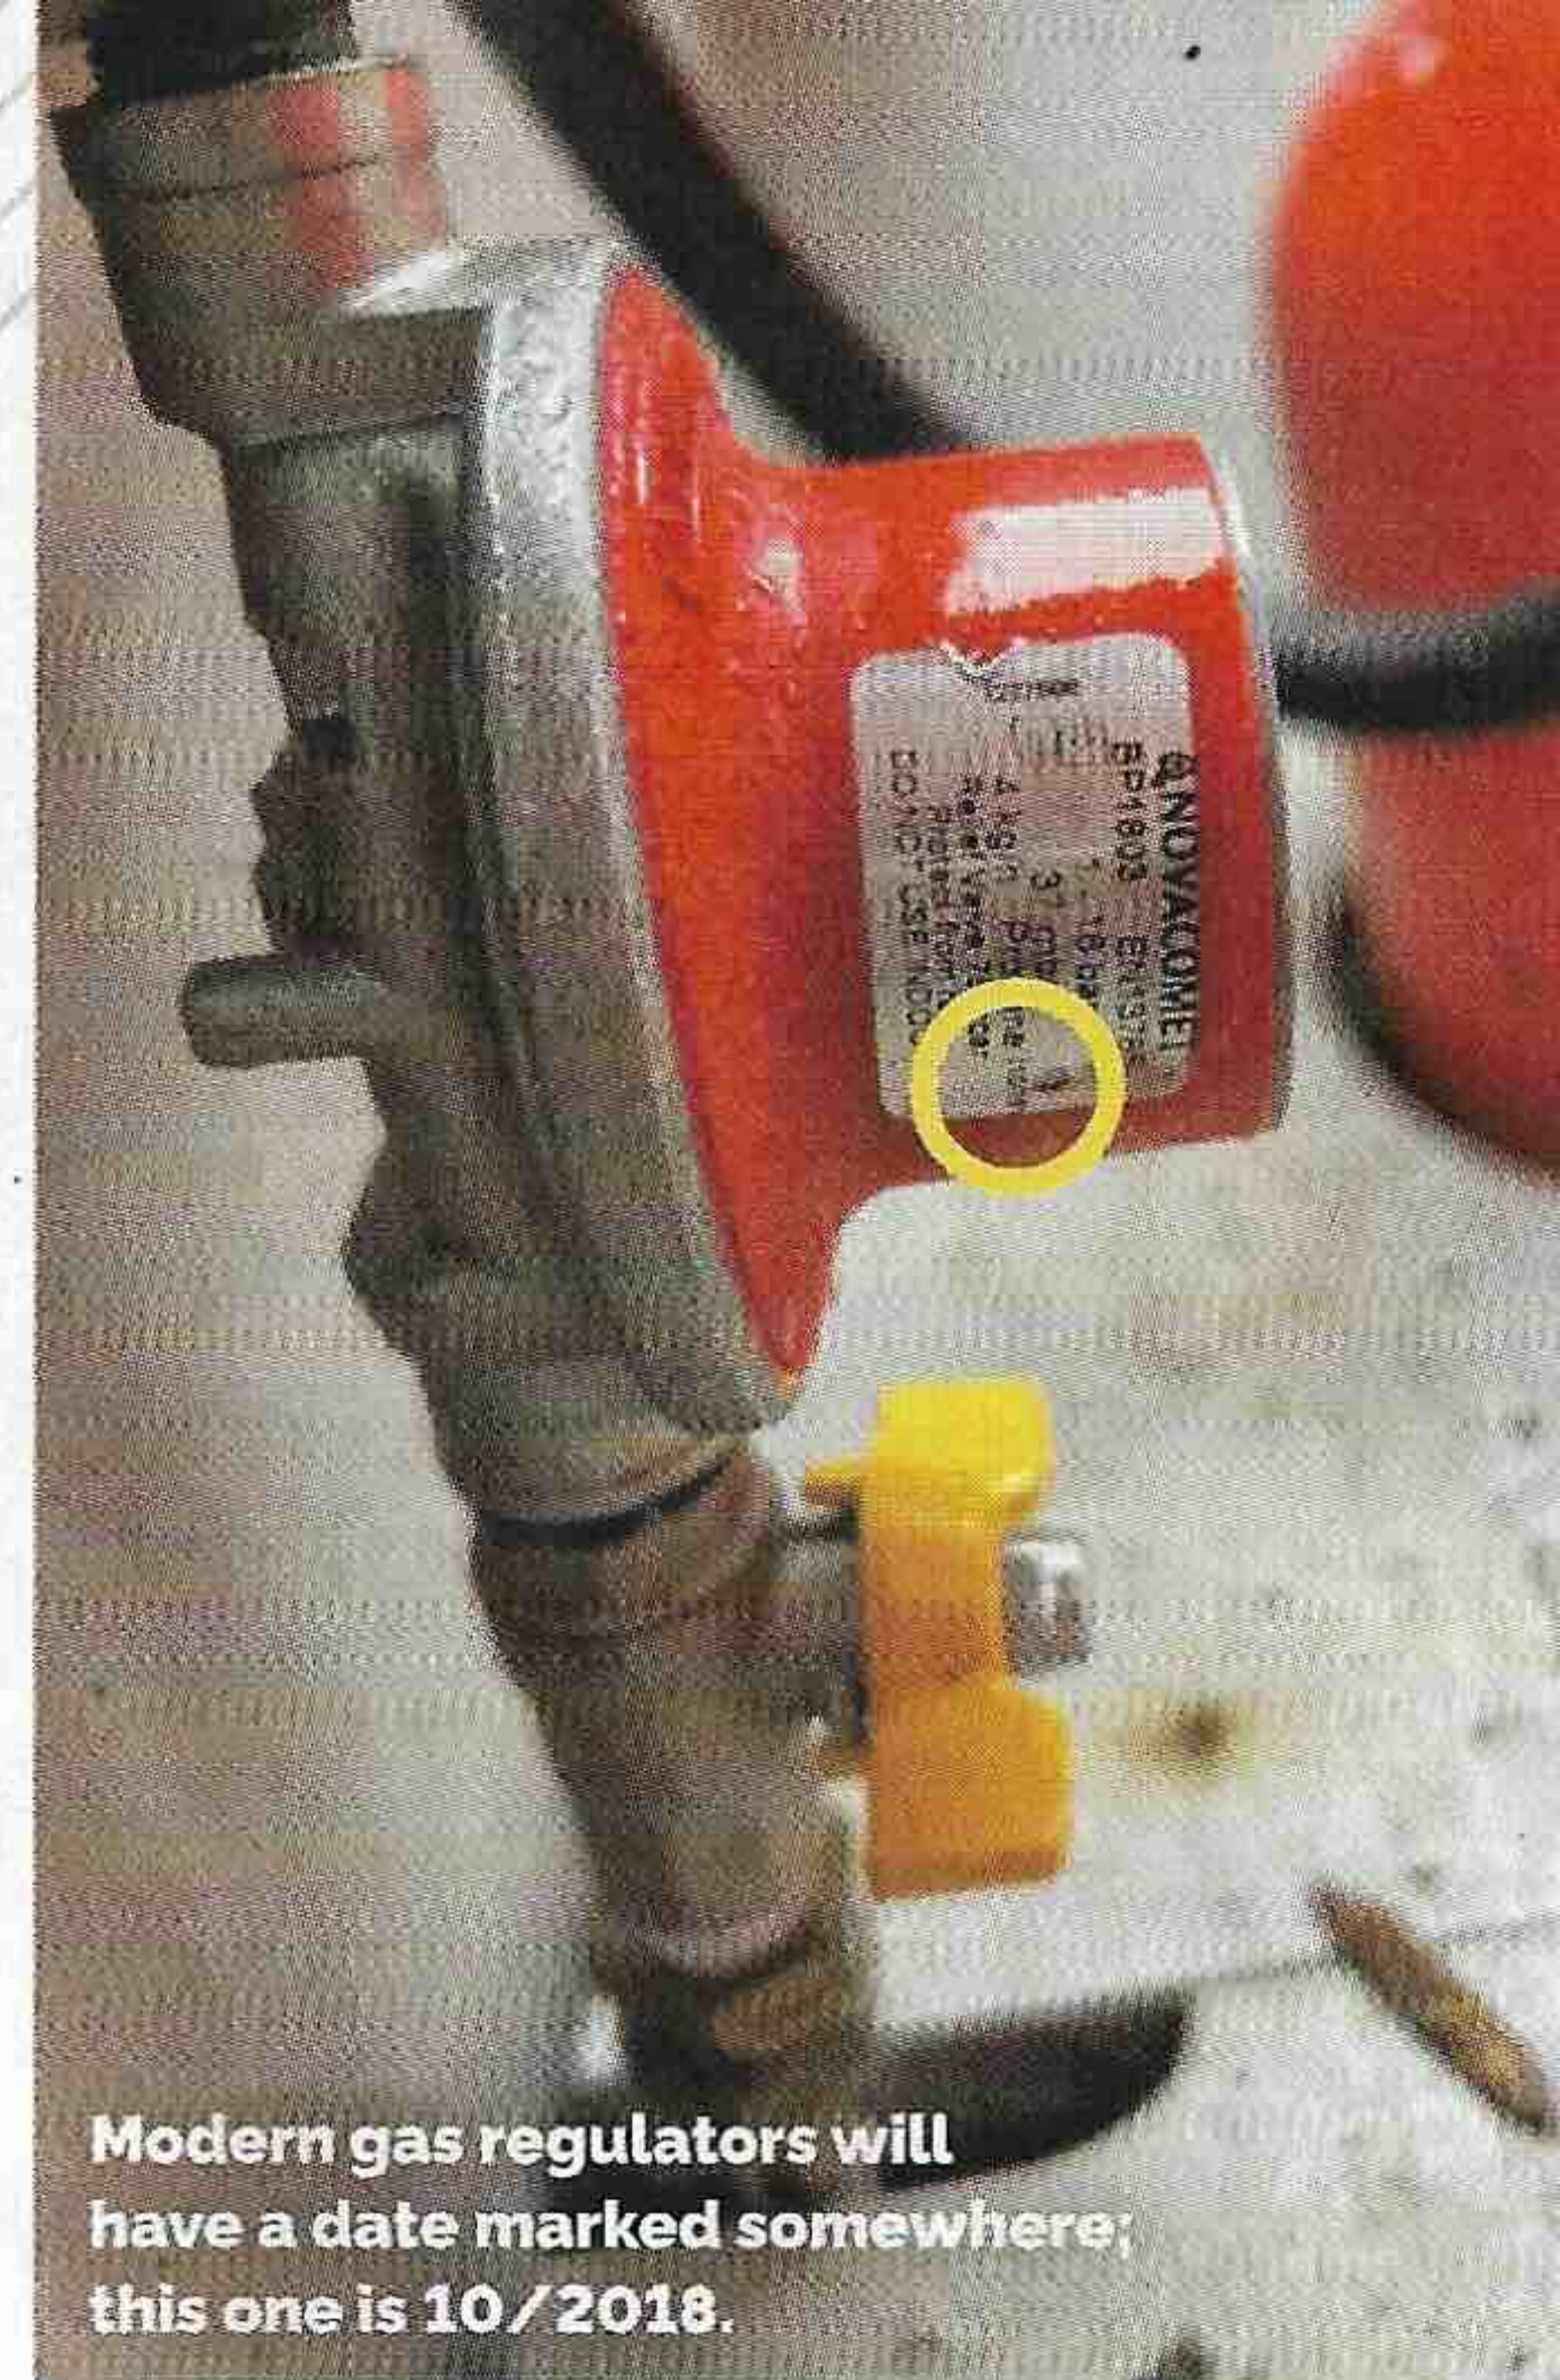
Modern gas regulators will have a date marked somewhere; this one is 10/2018.

Hoses and regulators need regular inspection and periodic replacement. A faulty regulator can lead to excessive gas pressure causing damage to appliances and a risk of fire and explosion. Conversely, low pressure can lead to poor appliance operation and a potential carbon monoxide (CO) risk. The industry struggles to give a timeframe for replacement but seems to agree on a ten-year service for regulators. Hoses may last for longer or shorter periods – look out for cracks on

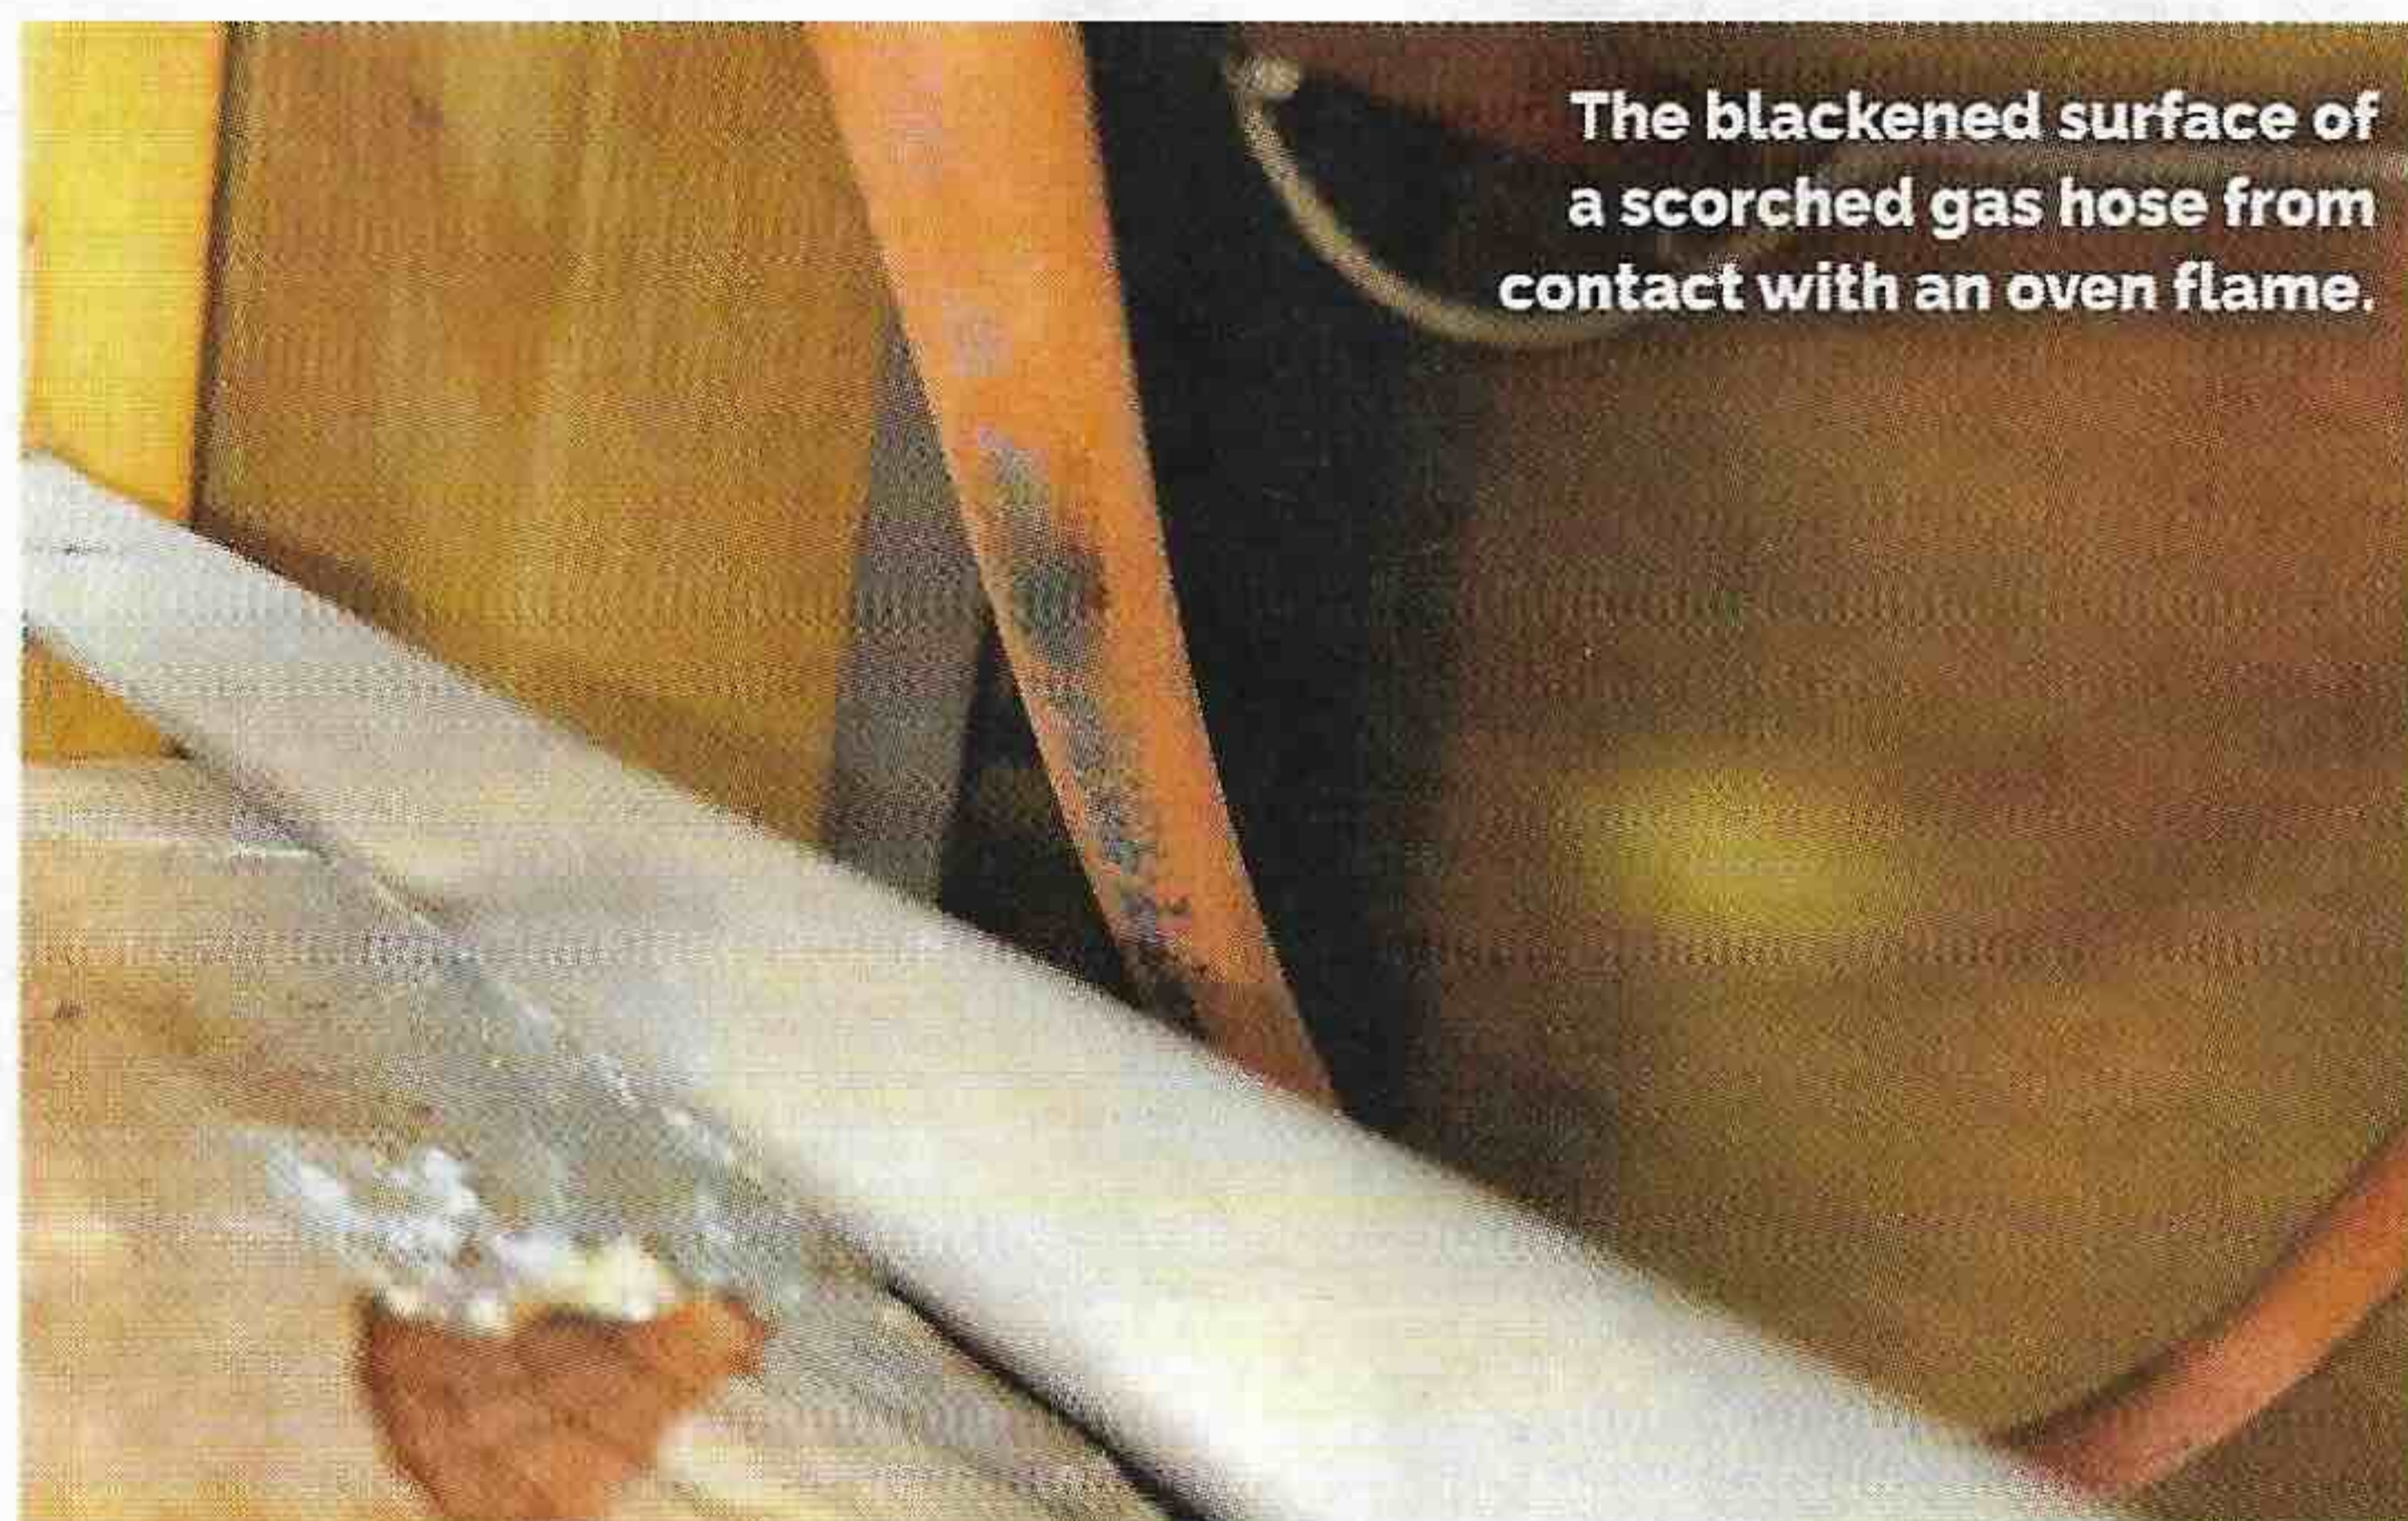
The blackened surface of a scorched gas hose from contact with an oven flame.

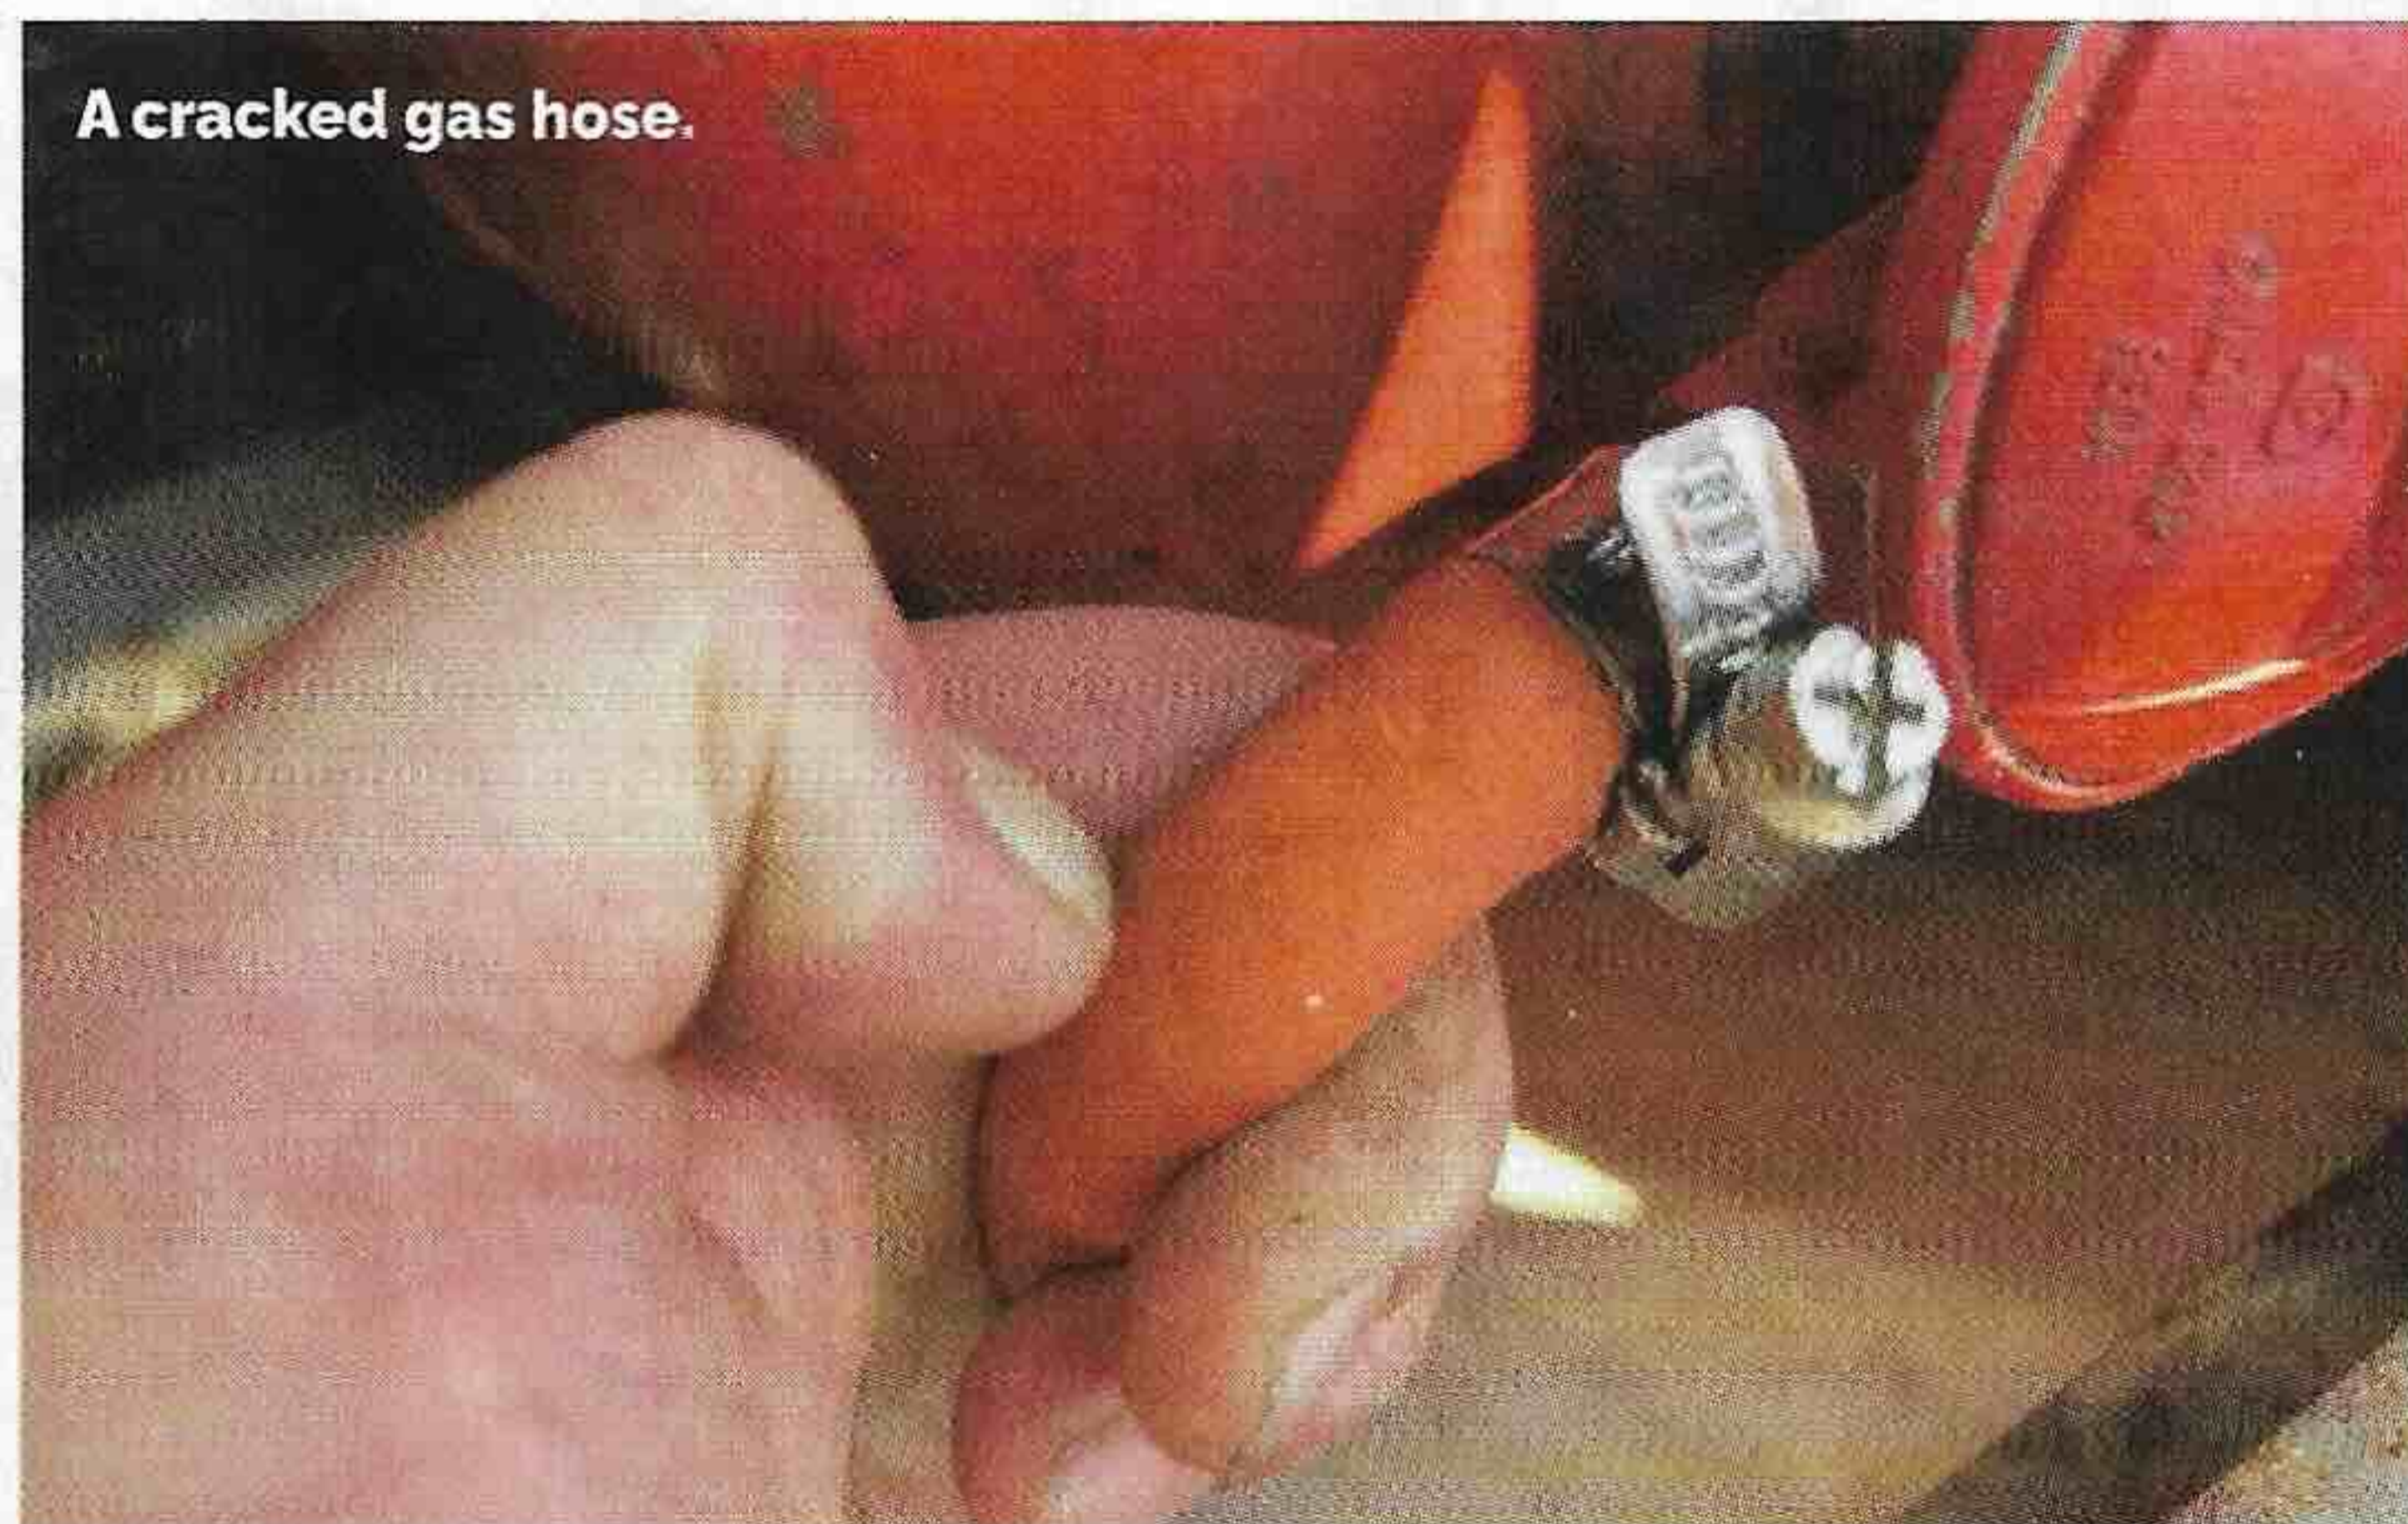
A cracked gas hose.

bends. The oldest in-service hose found recently was from 1973.

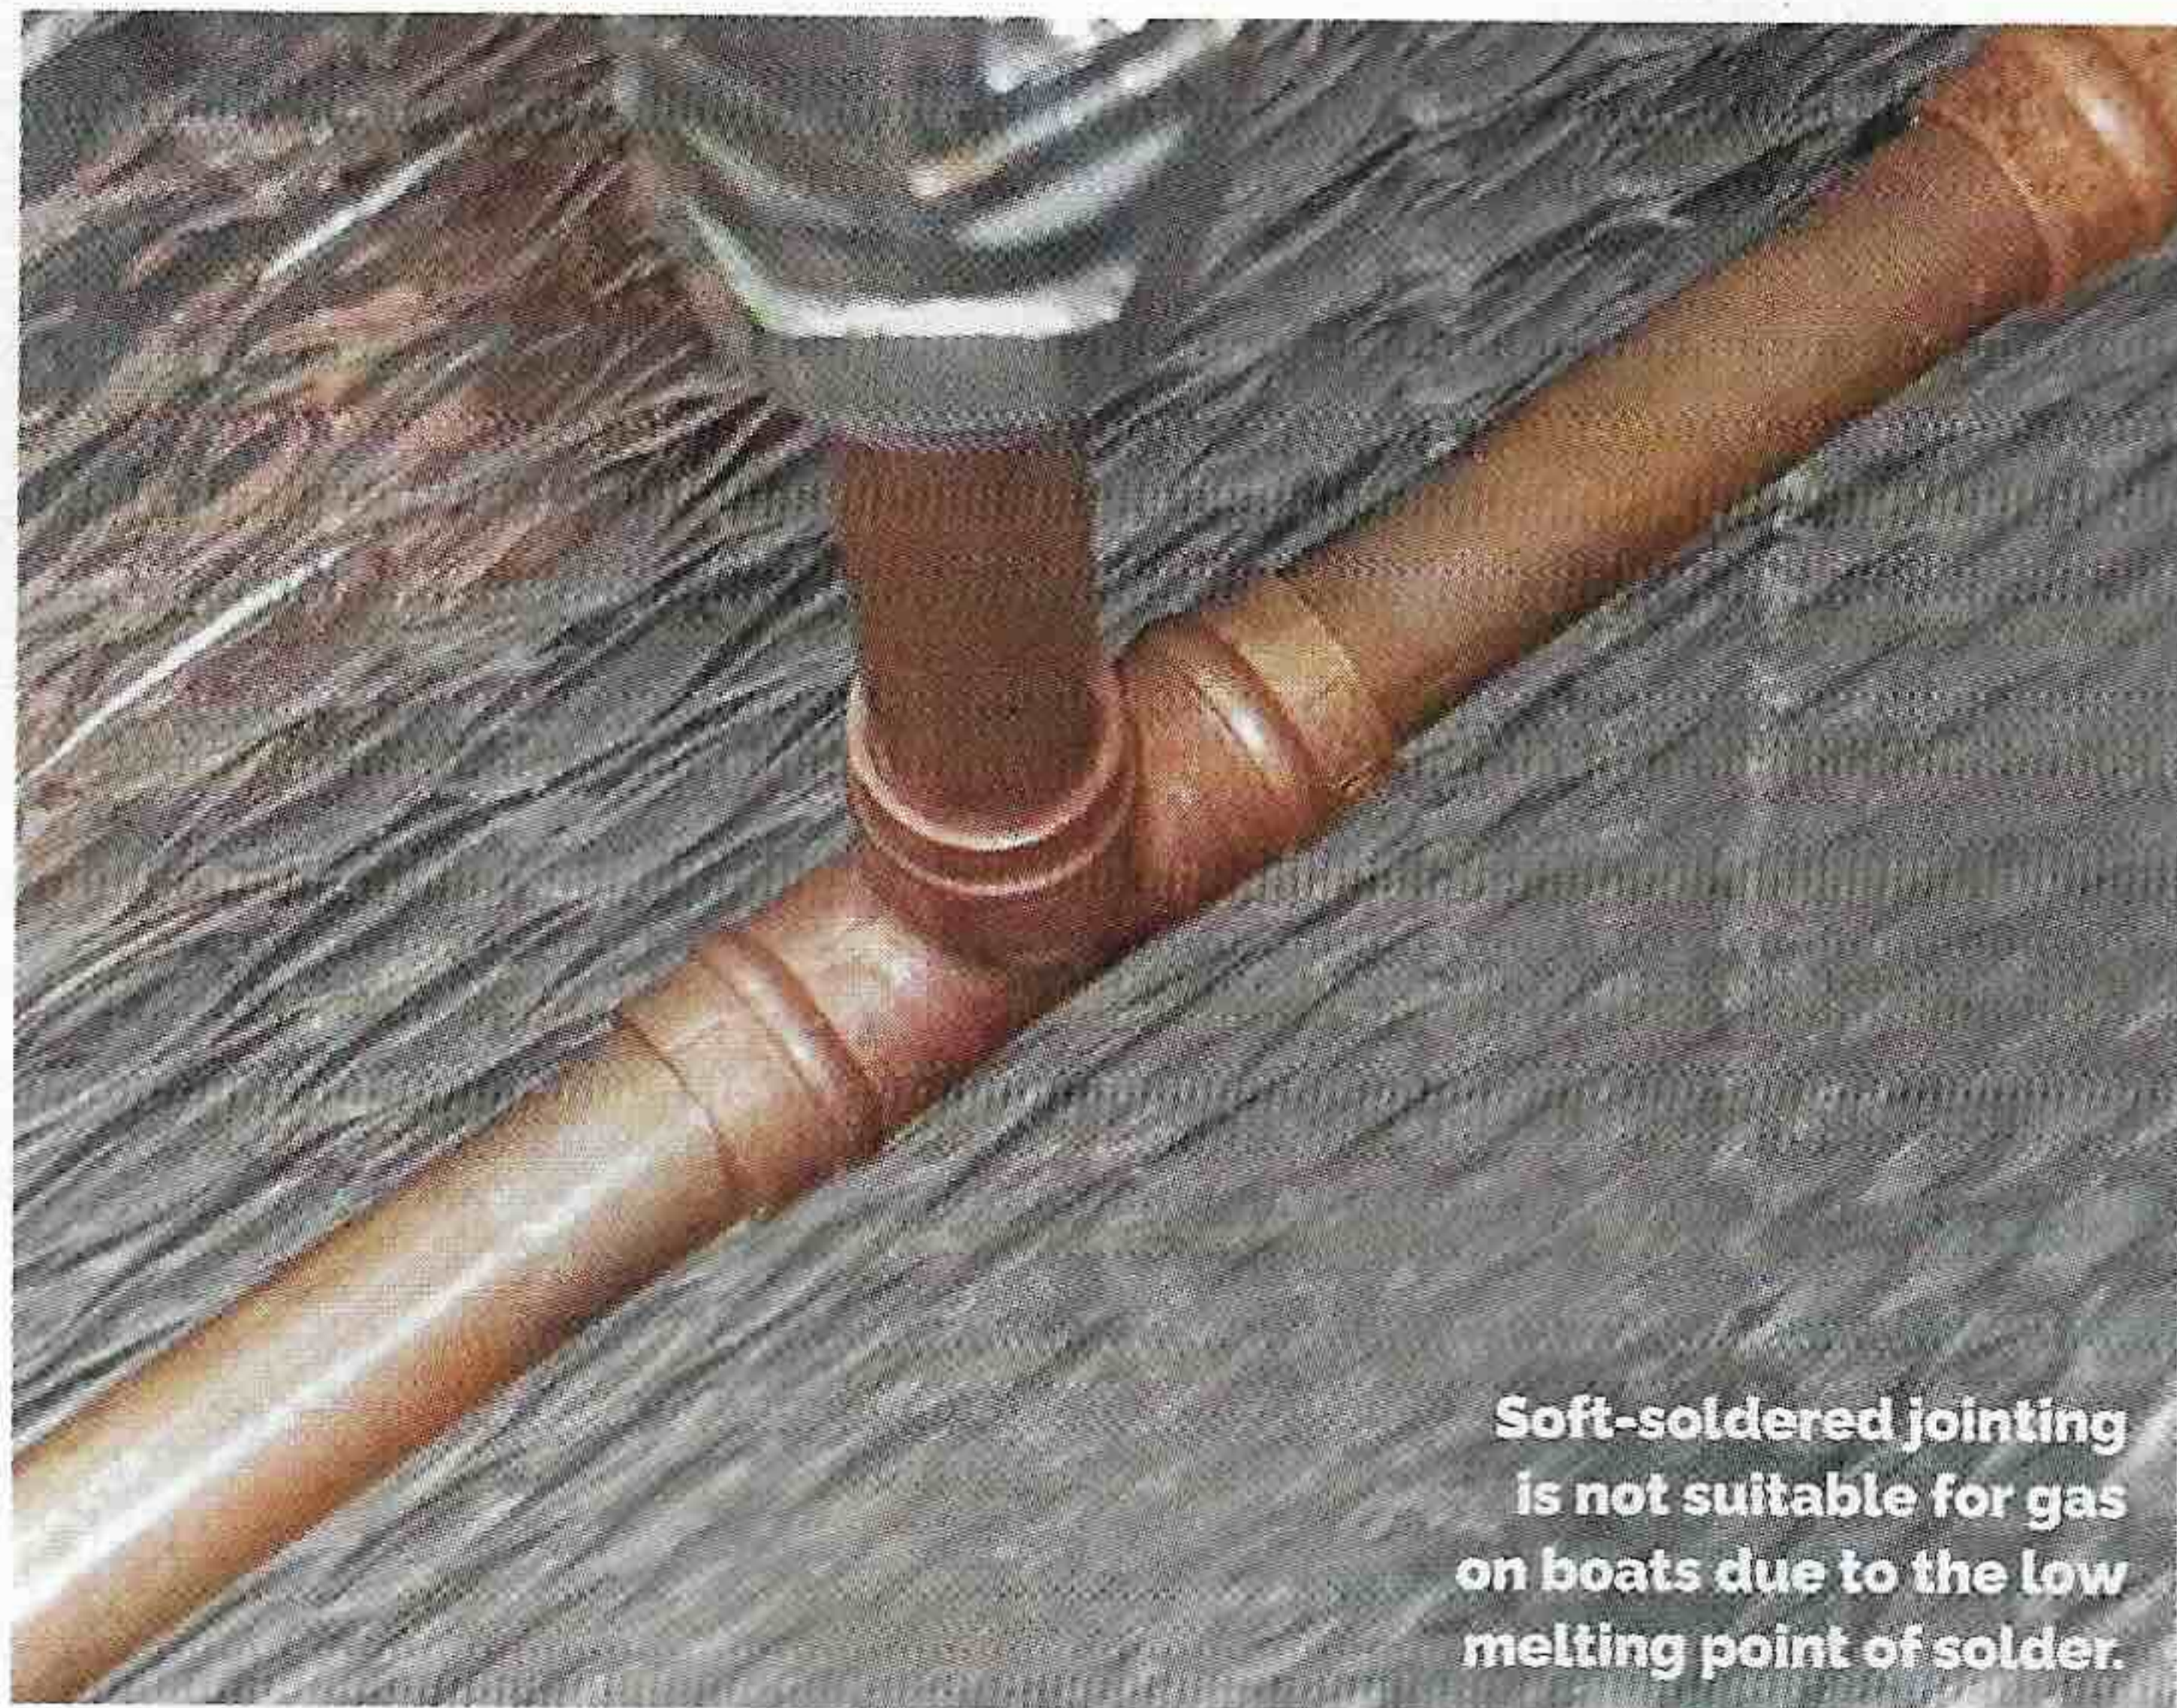
Soft-soldered jointing is not suitable for gas on boats due to the low melting point of solder.

Piping needs to be in good condition and secured against movement; aim for support every 500mm. Joints – mainly compression or screwed – need to be correctly made and supported within 150mm of each side. Research showed a direct correlation between piping/

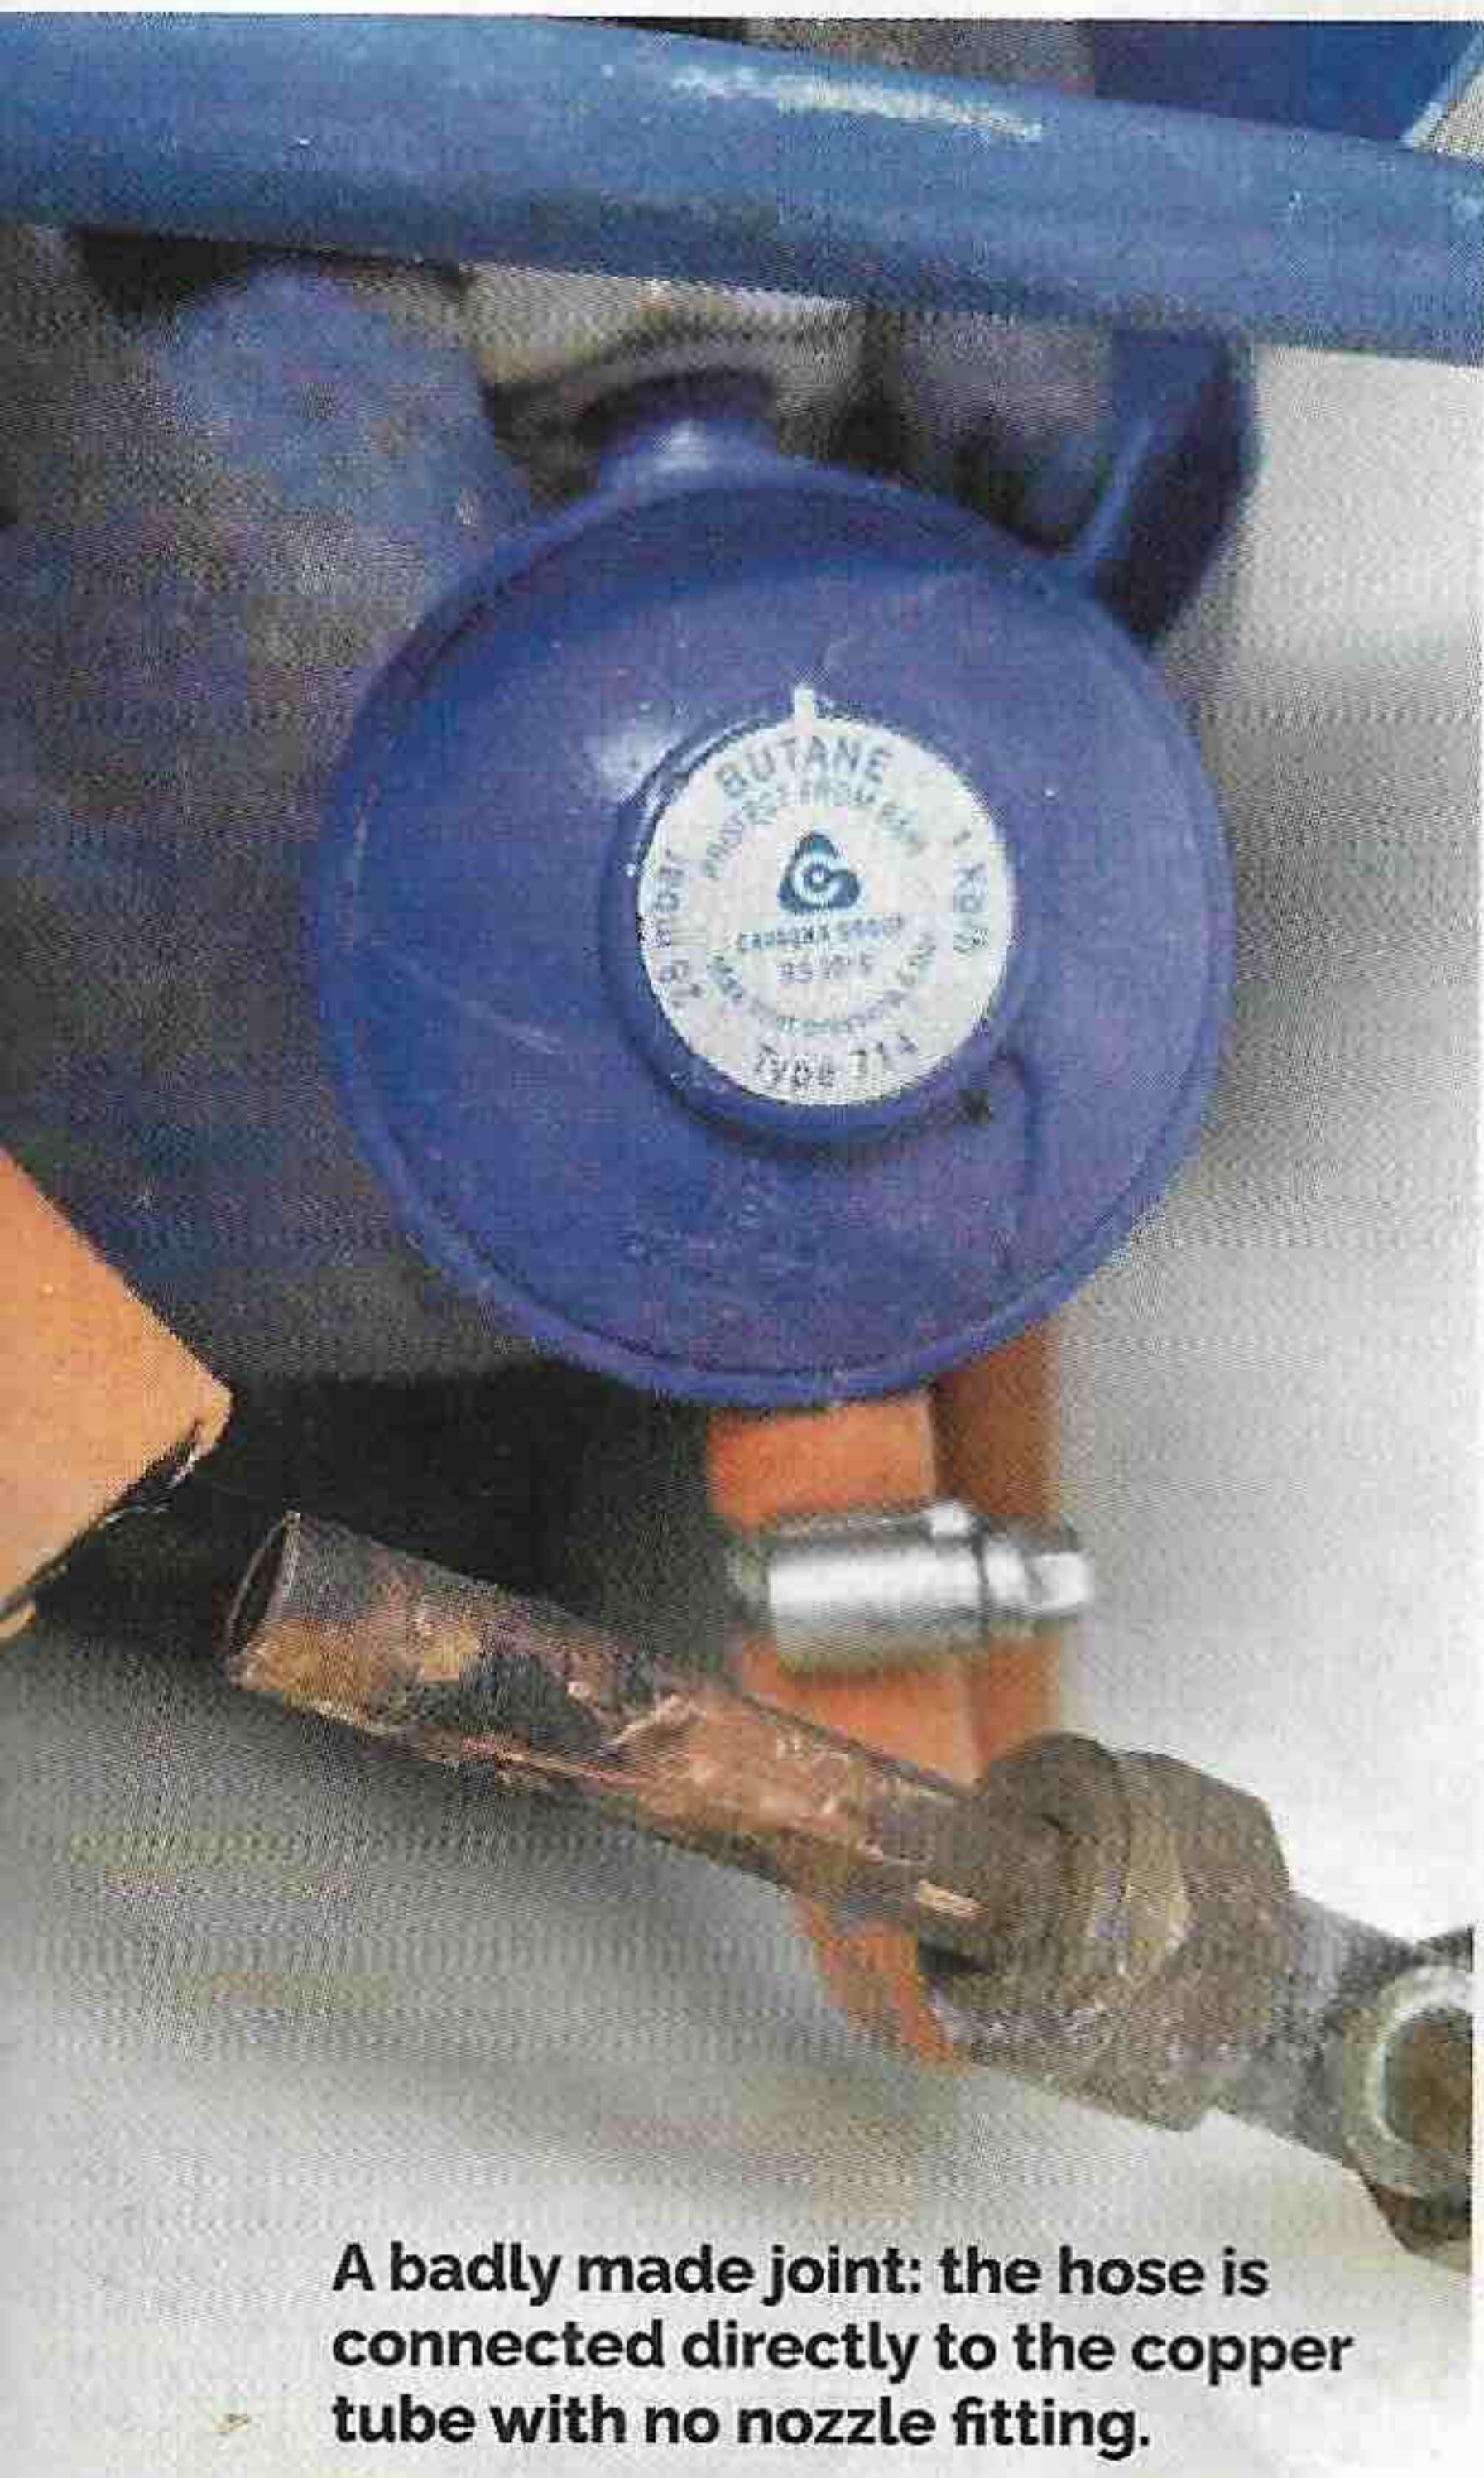
A badly made joint: the hose is connected directly to the copper tube with no nozzle fitting.
