Waterways World

GAS SAFETY: the need for servicing

Don't rely solely on your BSS exam for onboard gas safety. Research by **Tom Keeling** – a registered gas engineer and Chartered Marine Engineer – shows why it's no substitute for regular servicing

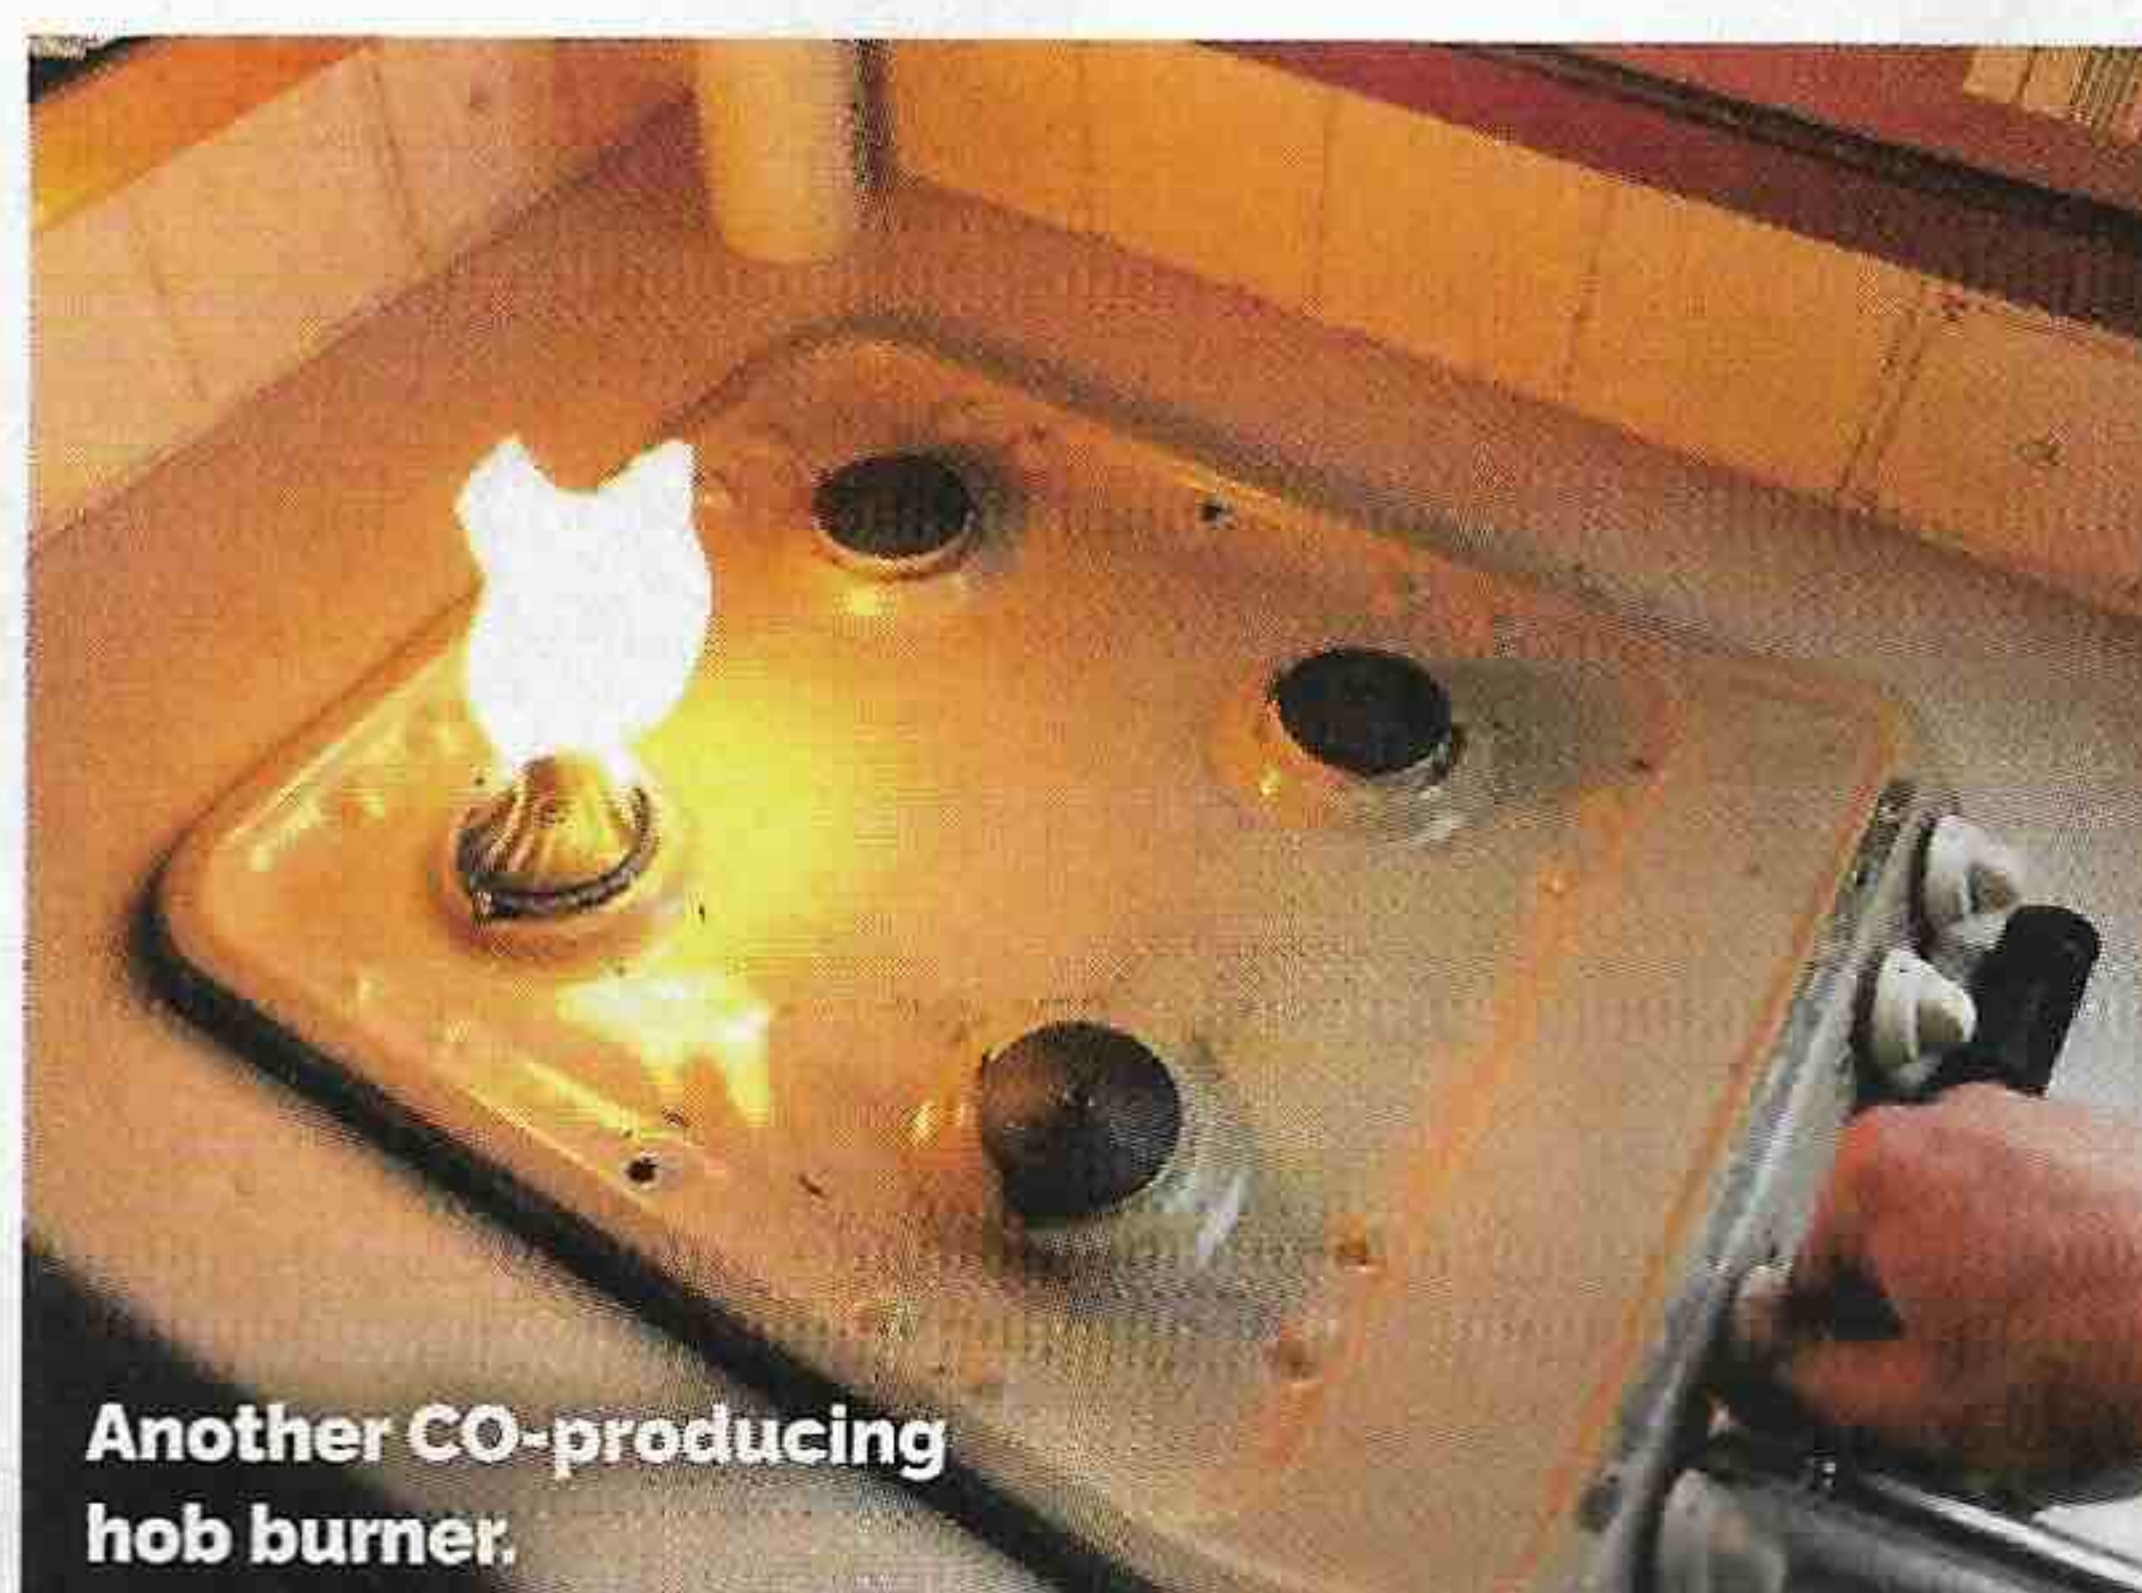
Another CO-producing hob burner.

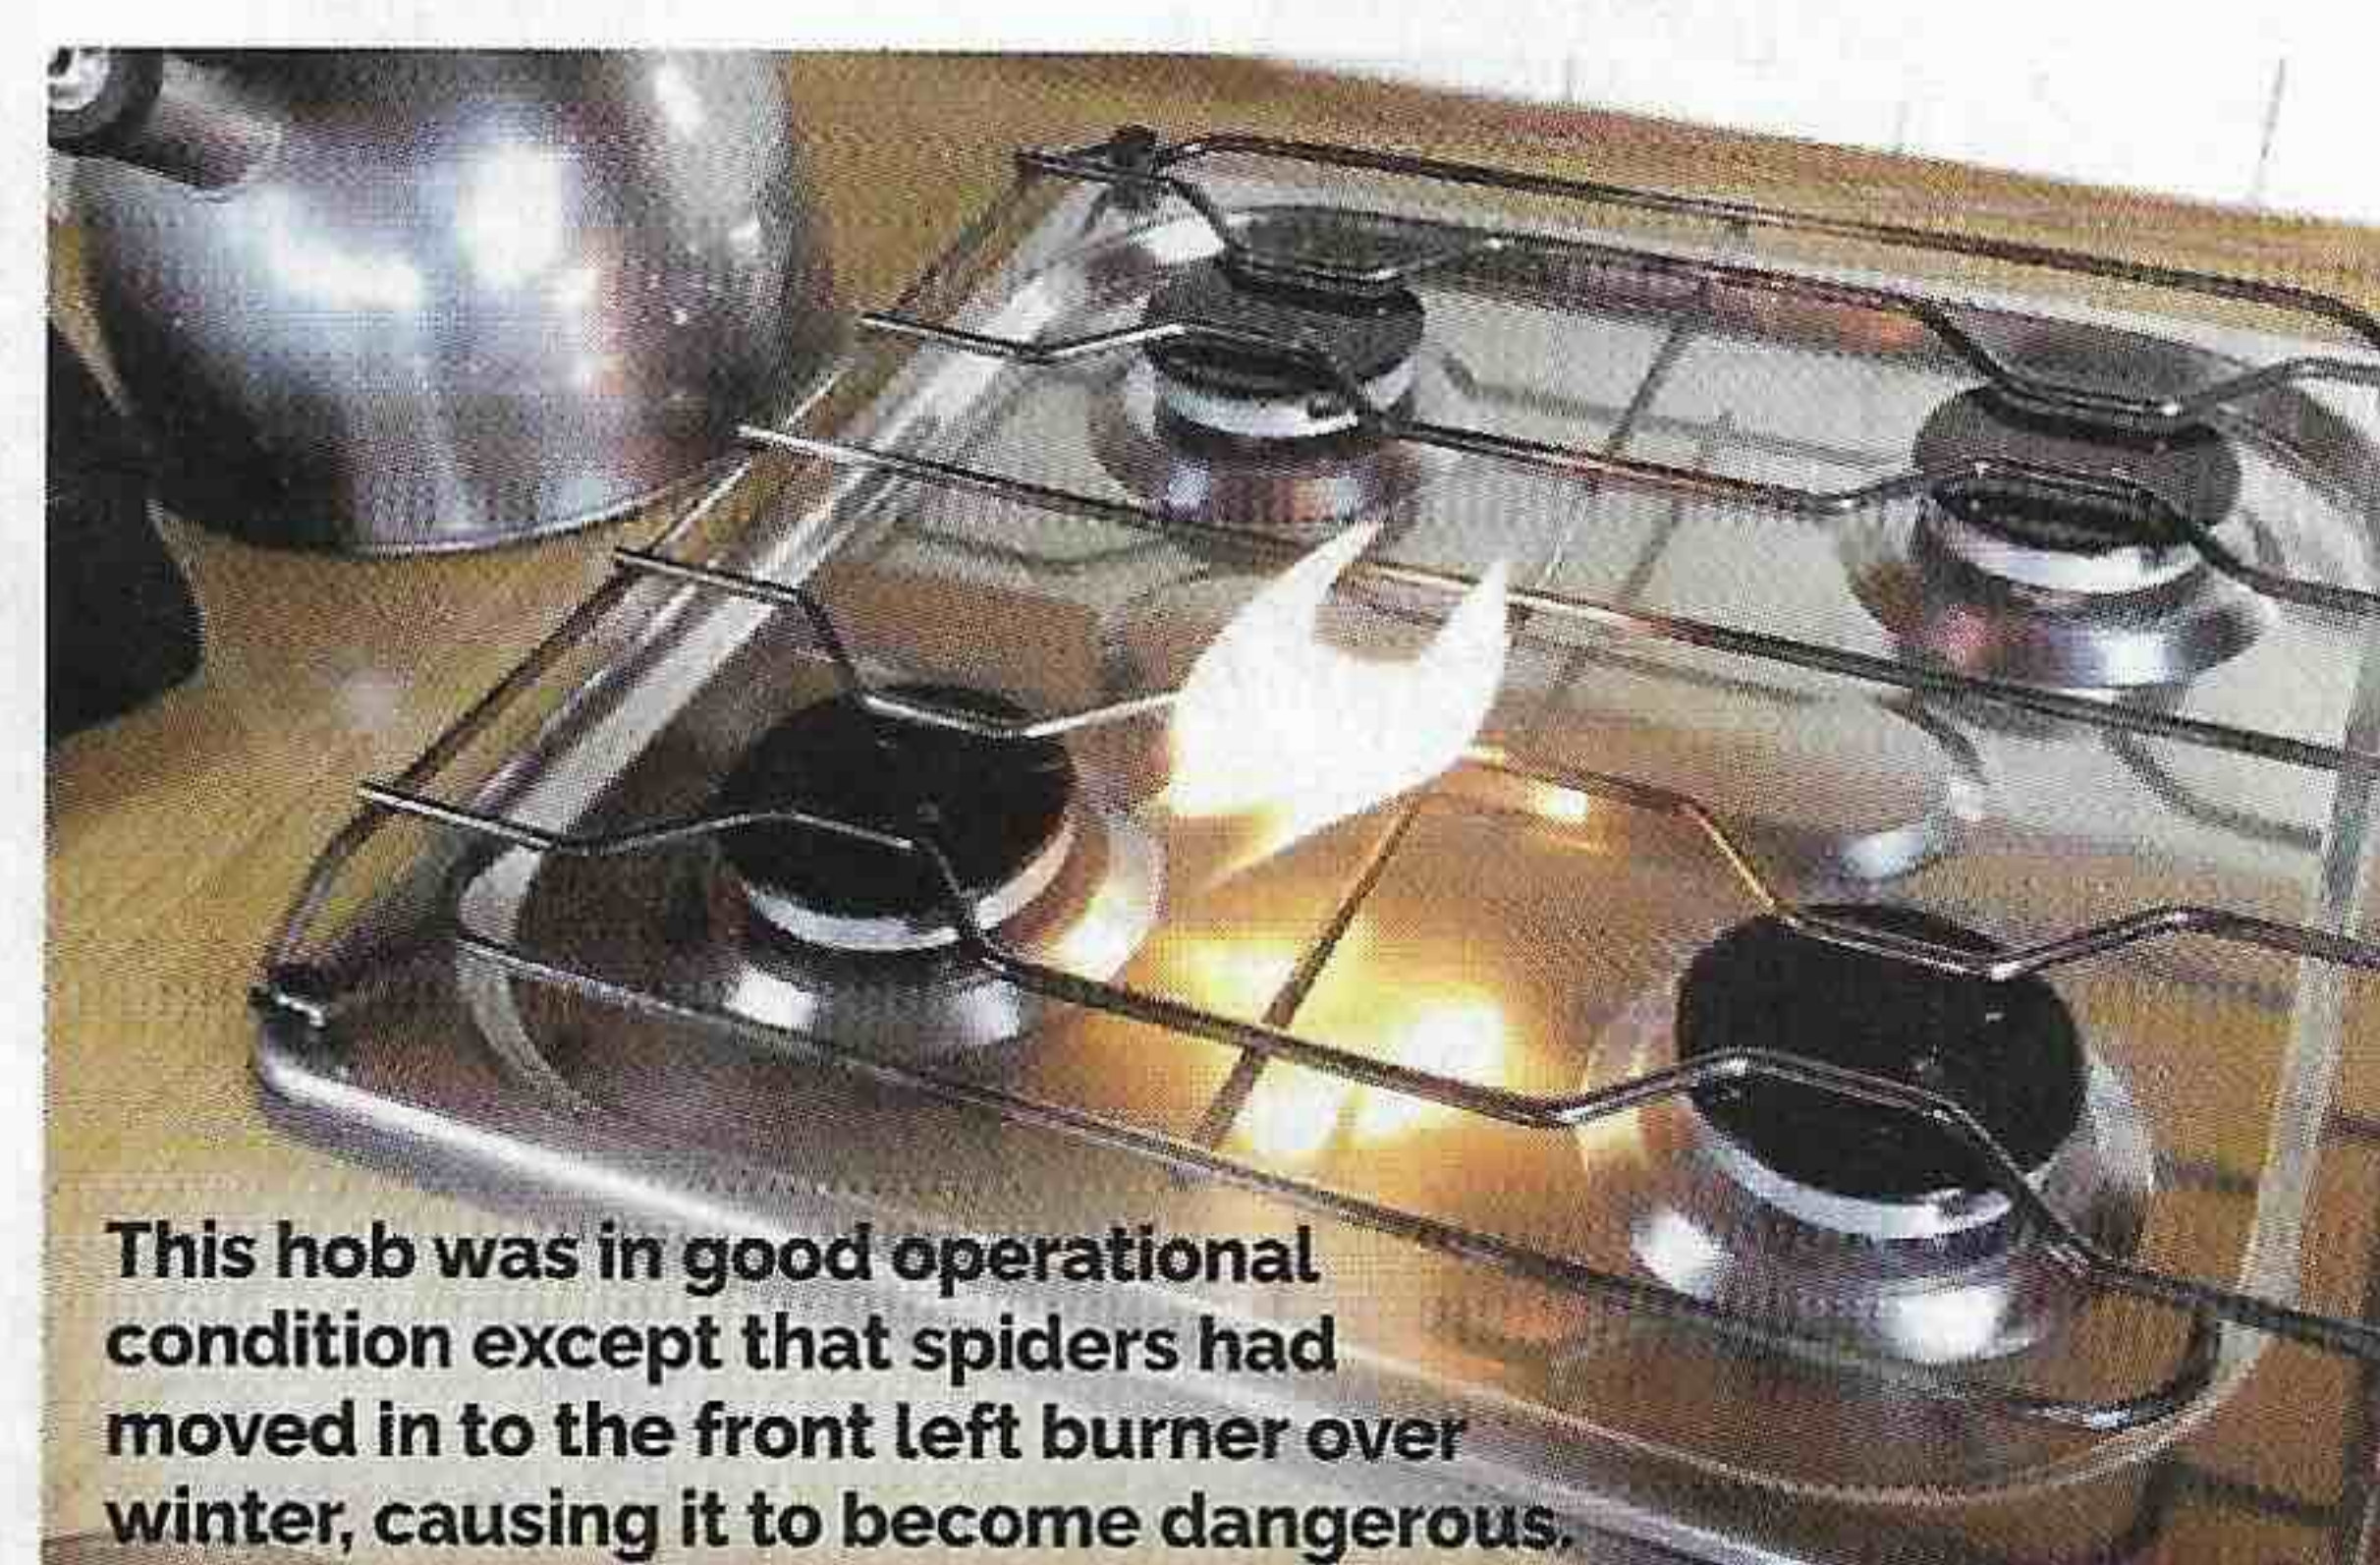
This hob was in good operational condition except that spiders had moved in to the front left burner over winter, causing it to become dangerous.

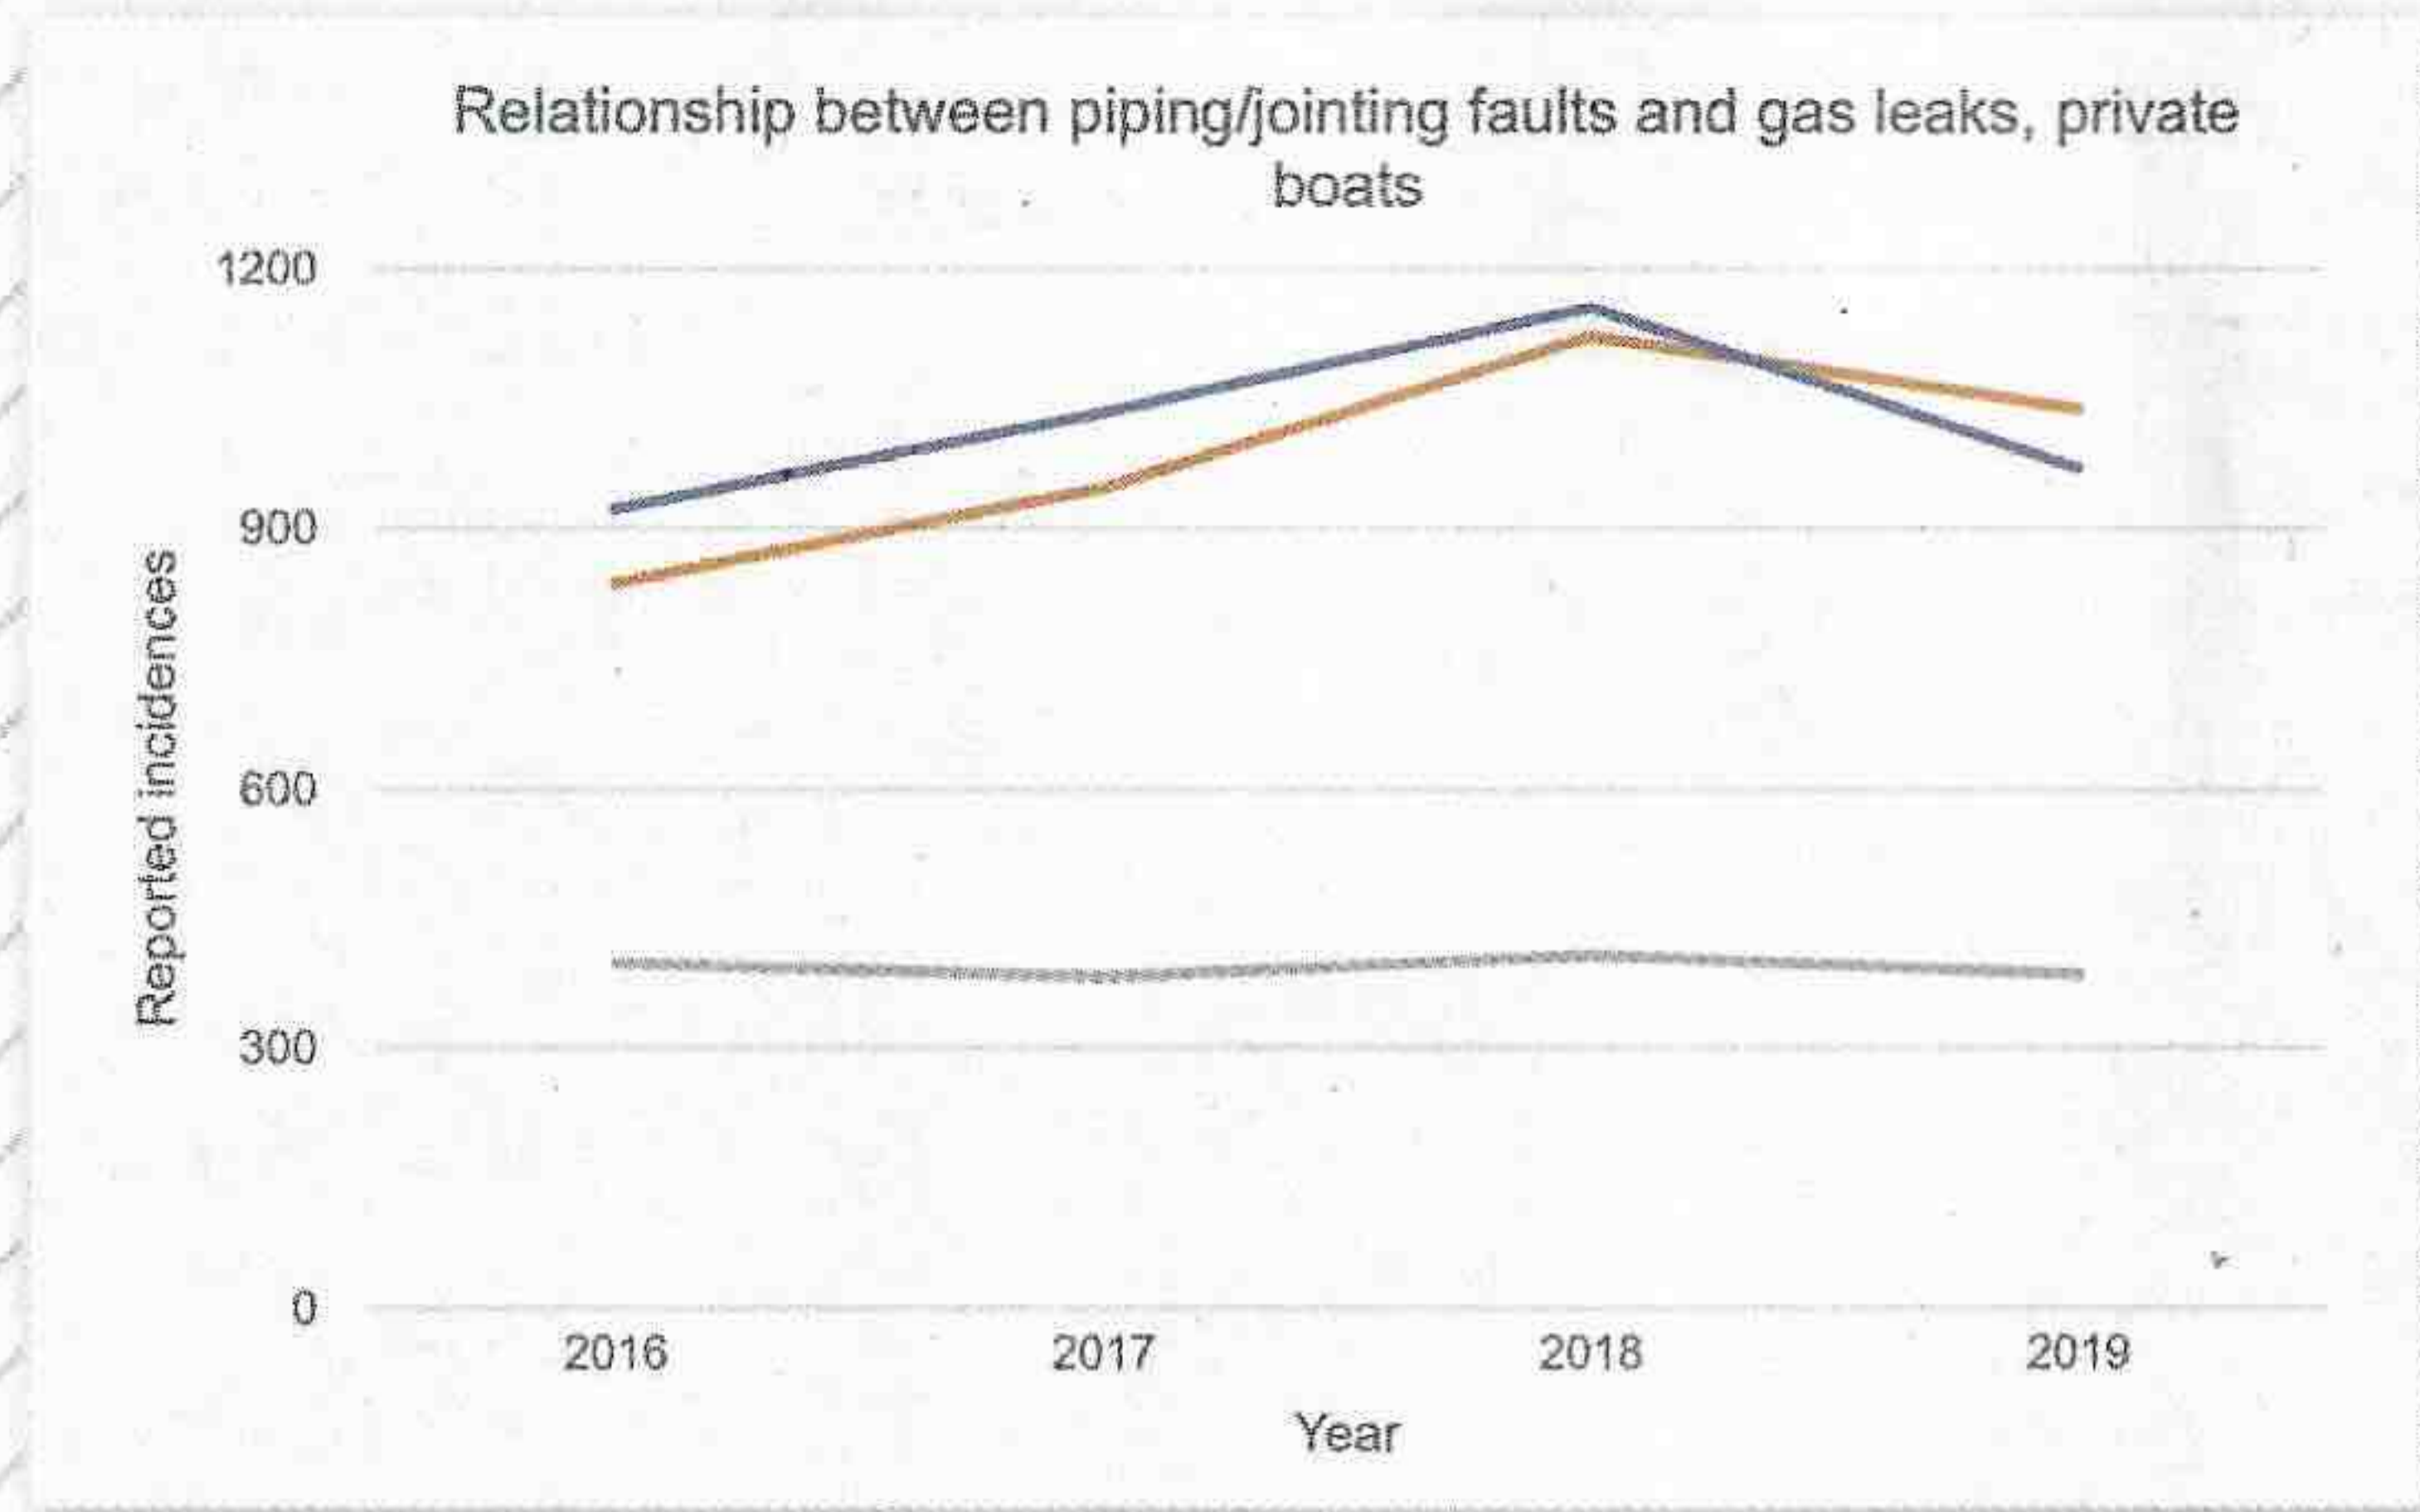
The graph above shows gas leak data as reported to the BSS defined by boat use (private or hire). Overall, it shows private boat gas leak incidence increased, dipping slightly during Covid-19. The data shows private boats experience greater amounts of gas leaks; hire-boats are required to be assessed annually.

The increase in leak incidence can generally be attributed to more intense use coupled with poor workmanship. A registered gas engineer can visit your boat and complete a safety check of the gas system on board, including testing for gas tightness; typical costs are £60 to £150, plus VAT. Engineers can be found via the Gas Safe Register website.

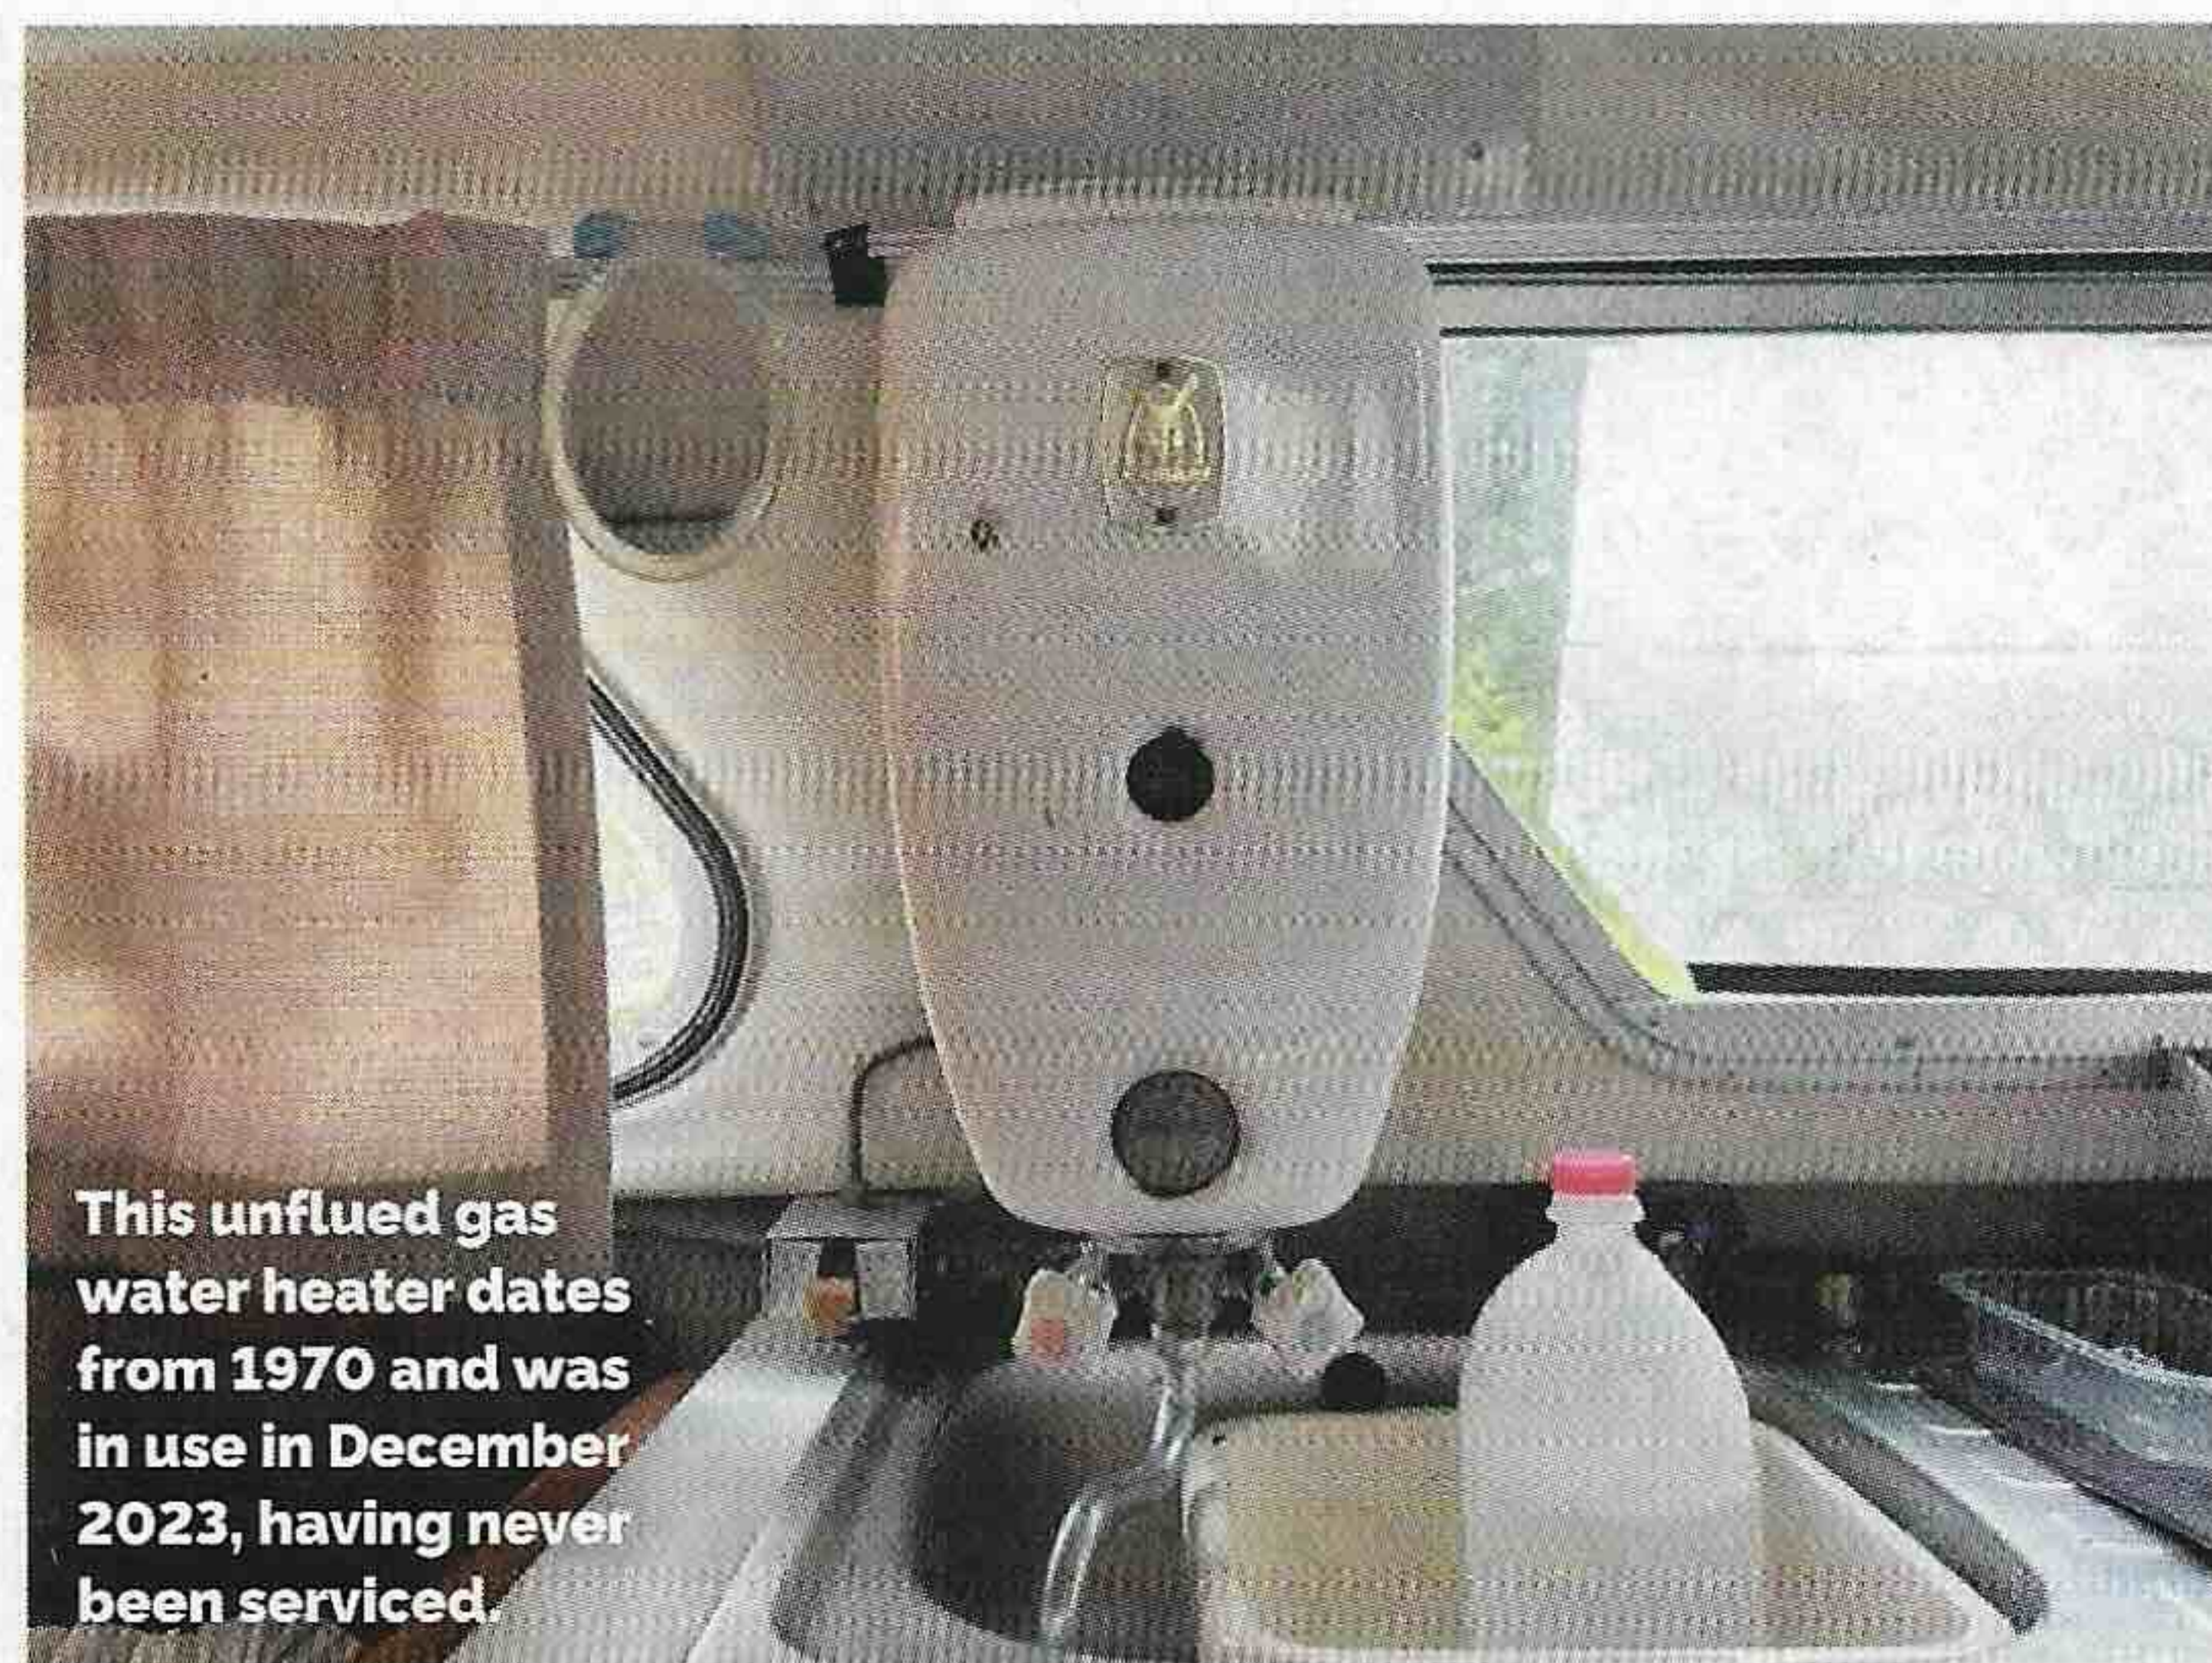
This unflued gas water heater dates from 1970 and was in use in December 2023, having never been serviced.
