## Bottom blacking is more than just arse covering...V1.0 06/10/24

By Tom Keeling – for customer use only

Welcome to my short explainer on why marine surveyors often recommend painting base plates, and thus grit-blasting and epoxy coating to all underwater plating on steel inland waterways vessels....

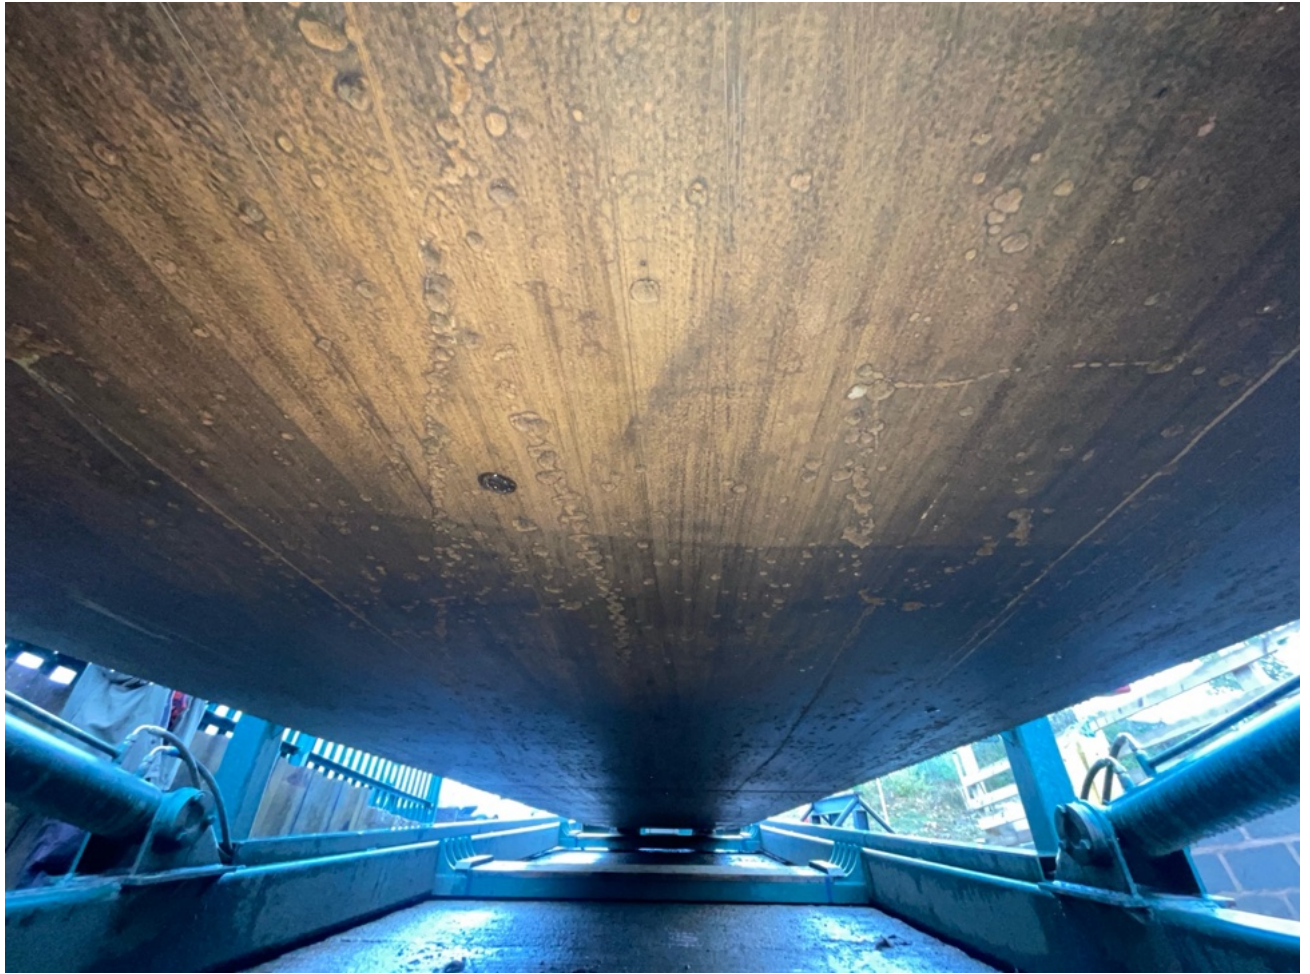
Longer view of the base plating showing the pitting arrested. Note a single graze exists to the right hand of the photo, otherwise the paint has resisted damage. This is a continuous cruiser, paint 5 years old at time of survey.

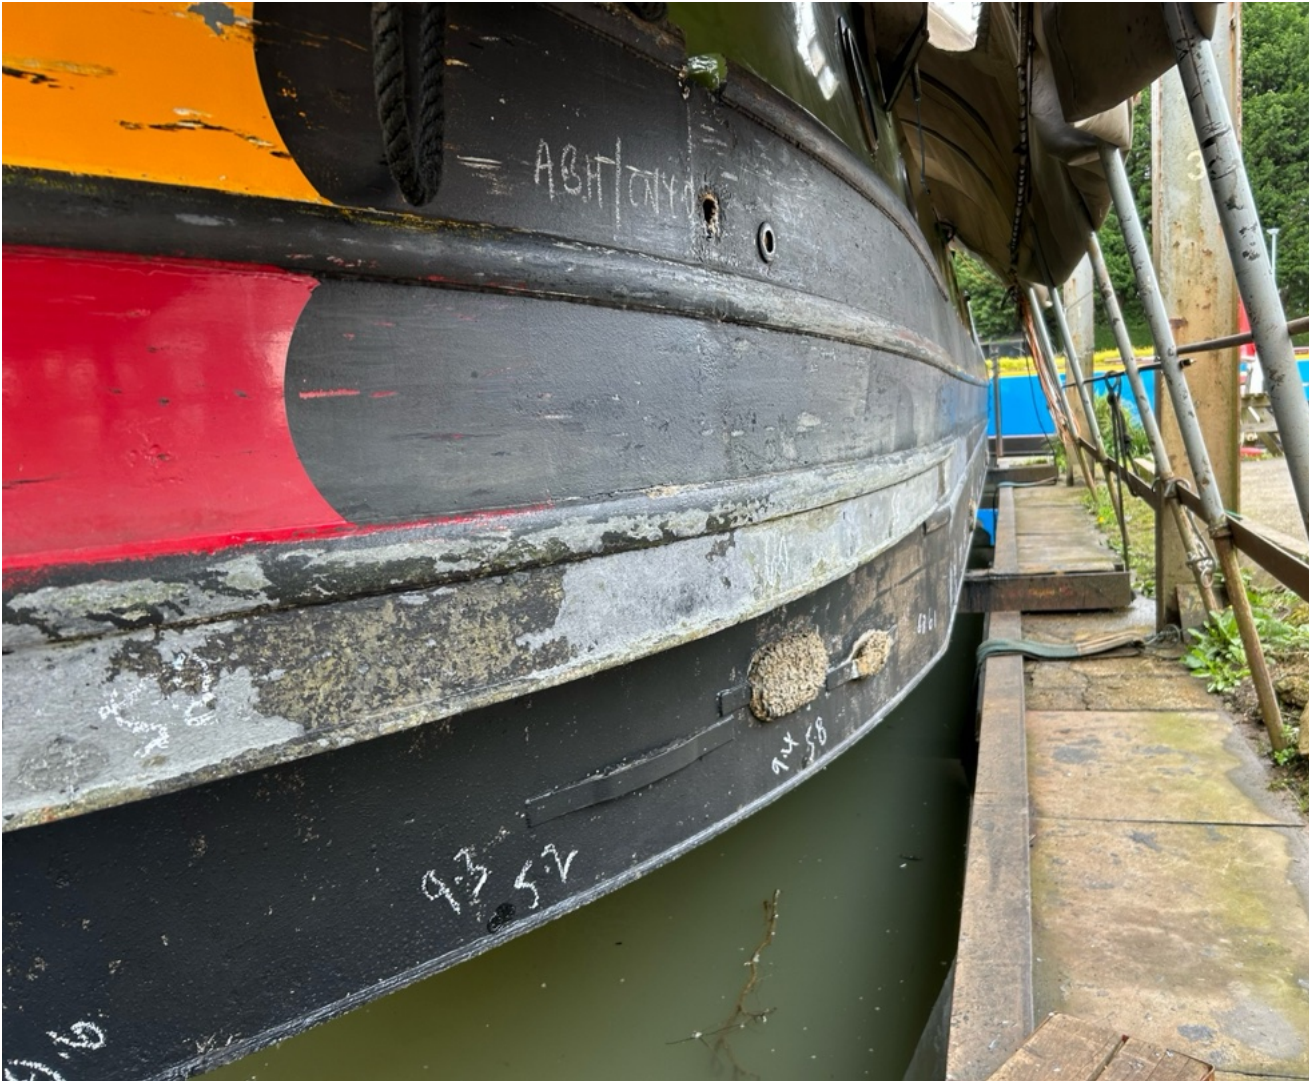
Paint damage to the starboard lower counter side reveals a silver-coloured zinc-coated hull, despite the paint failure the zinc coating is 100% intact and all pitting is arrested. The paint coating has become virtually aesthetic although it does of course add a layer of protection to the zinc.

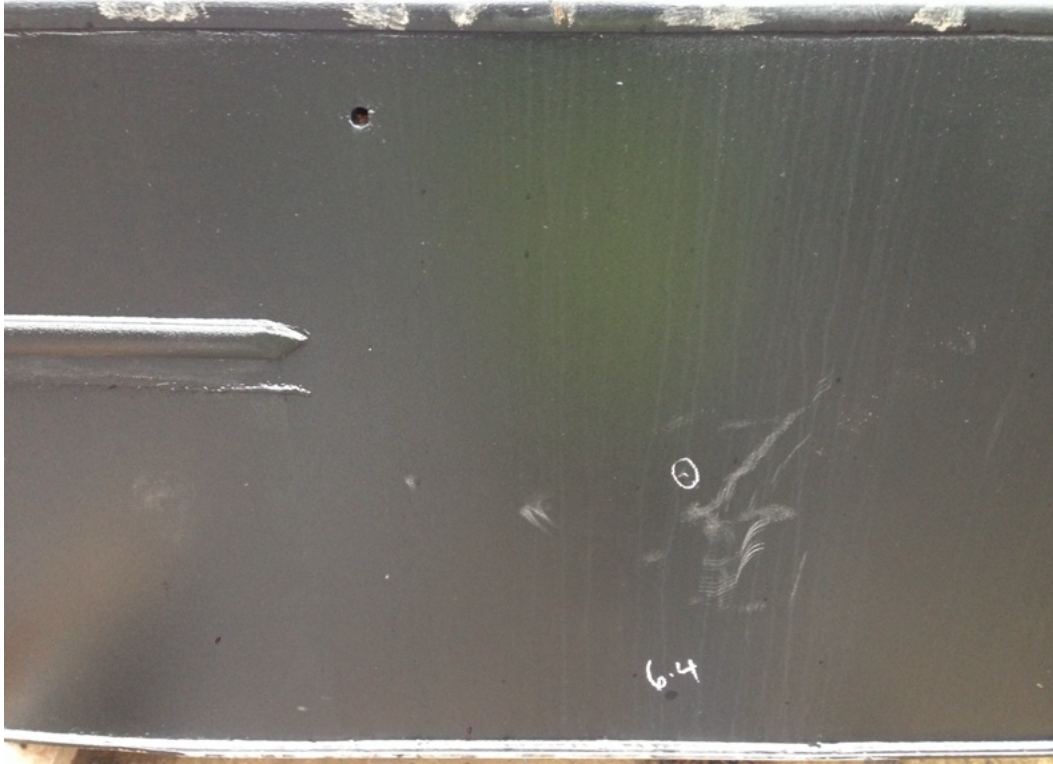
This 1992 narrowboat was grit-blasted and epoxy coated from new. In 2014 it was surveyed and found to have only x 1 pit at 1.5mm.

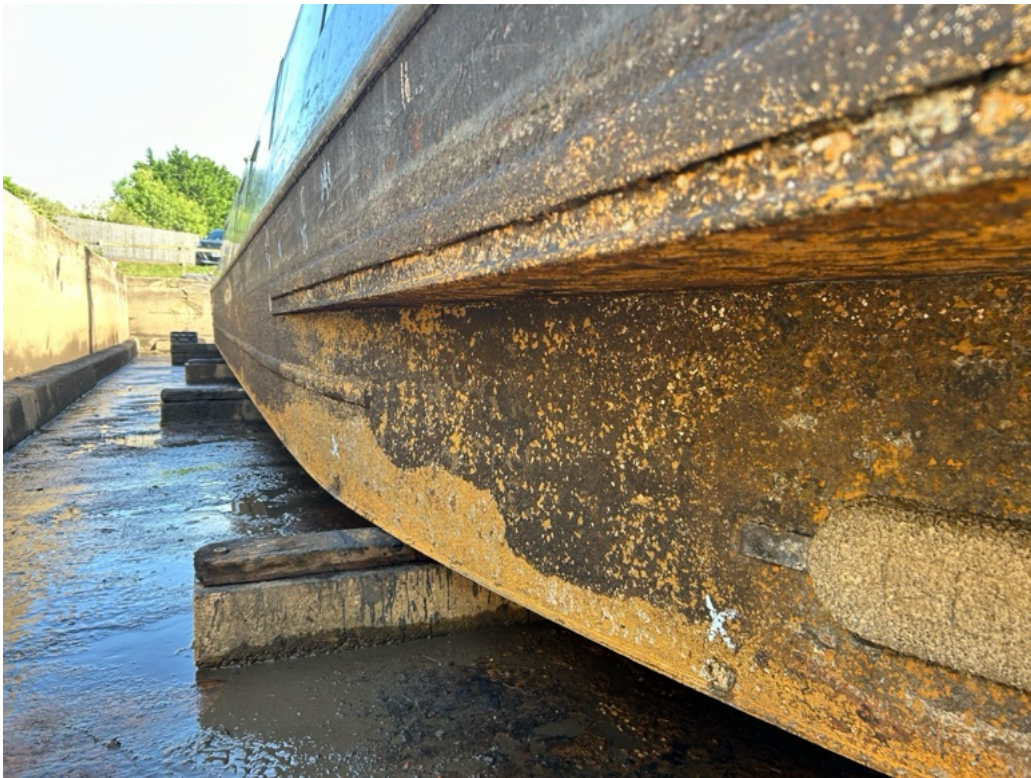
This 20-year old narrowboat has had no maintenance and was covered in pitting. The base plating was covered in over an inch of thick growth / debris / corrosion scaling
